MIDDLE TAMOR HYDROPOWER PROJECT (73 MW)

PROGRESS REPORT

(April 2022)

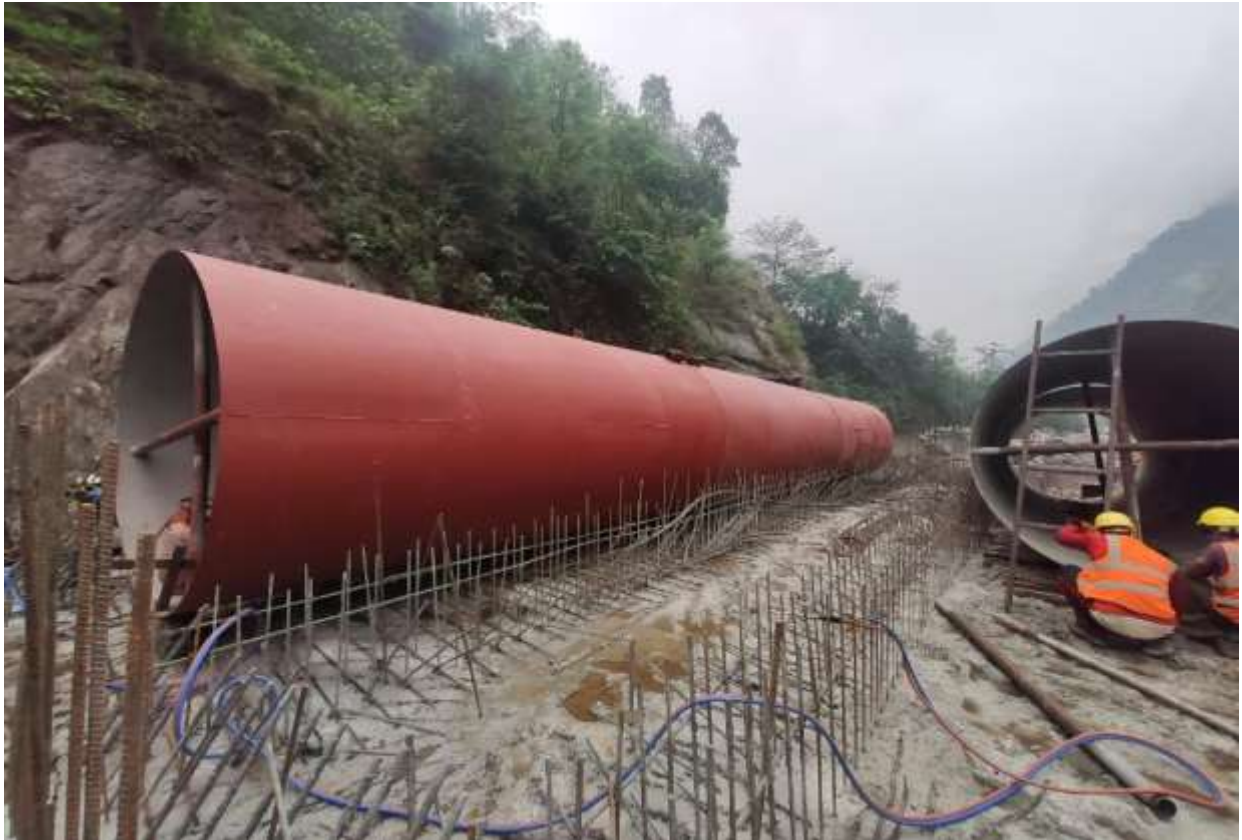
Figure 35: Erection of weir flushing pipe (ID: 2.25 m , thk: 12 mm)p

Additionally, flushing pipe at weir section has been added. The length of each unit is 15.76m and there are 2 units of weir flushing pipes. Fabrication of pipes is completed and erection works has been ongoing.

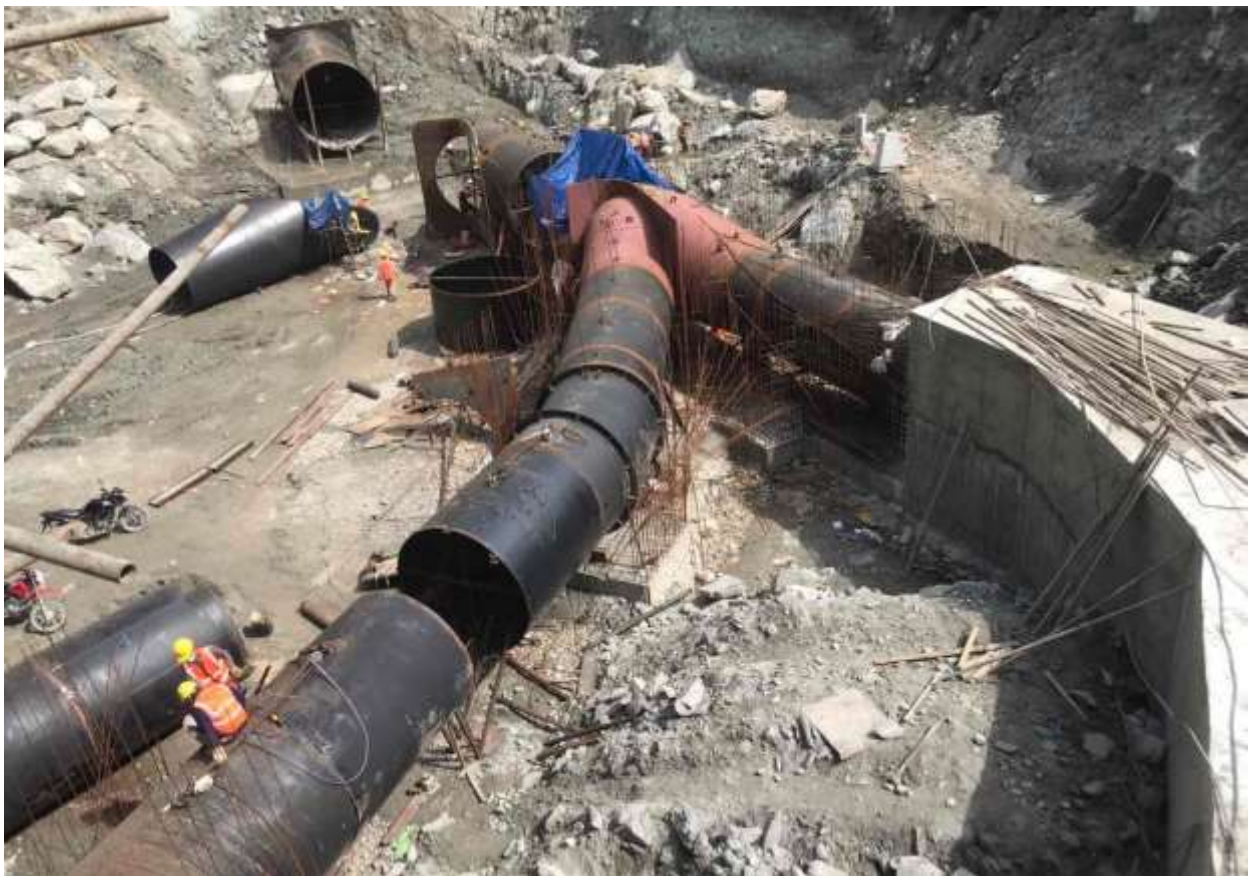
Figure 36: Bifurcation Unit 3 (Inlet Dia: 3.18 m, Outlet Dia: 2.25 m , thk: 25 mm)
