SANIMA MIDDLE TAMOR HYDROPOWER LIMITED

MIDDLE TAMOR HYDROPOWER PROJECT (73 MW)

PROGRESS REPORT

(November 2022)

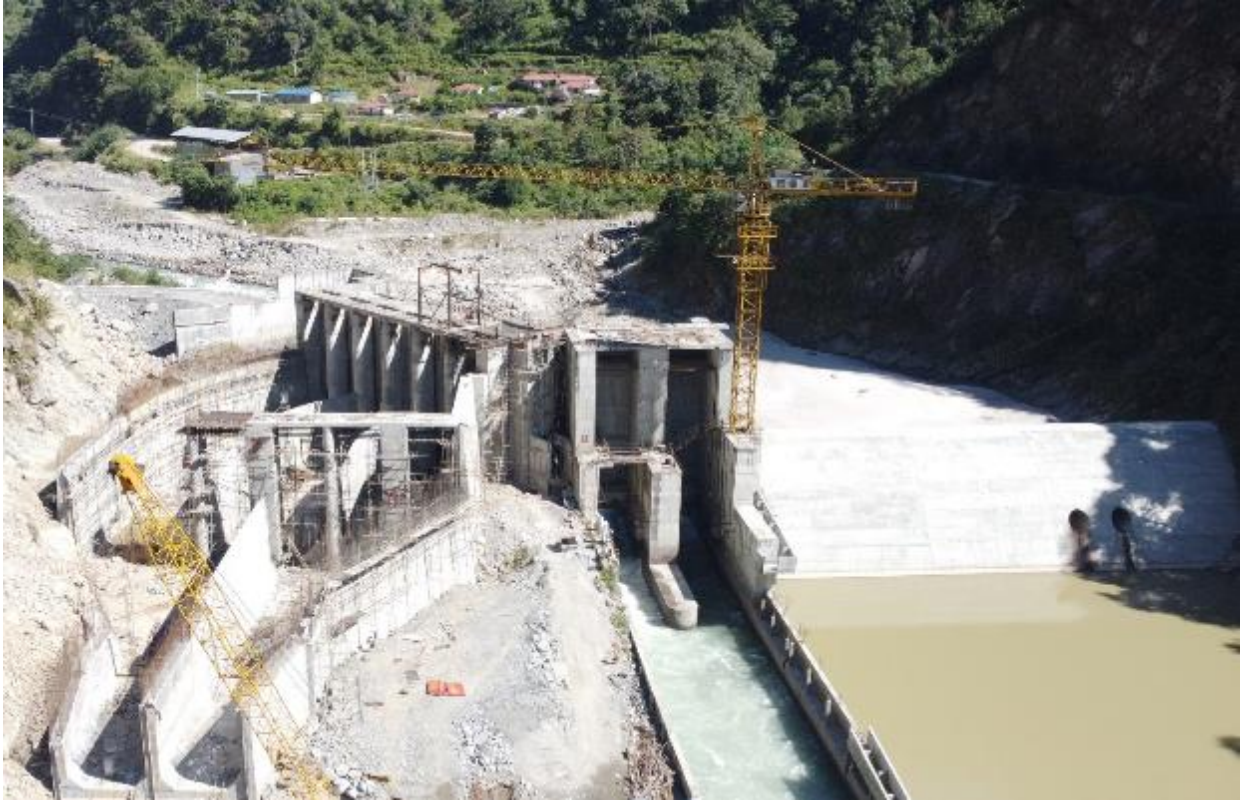
Figure 2-7: Concreting works at gravel trap and conveyance tank

More than 8,170 m³ of concrete has been poured at intake structure till date. About 4,607.48 m³ and 2,559.24 m³ of concrete has been poured at gravel trap and intake canal till date which is almost 96% and 95% of concreting works of the structures respectively. The rebar installation and concreting works at the intake wall (hillside) and piers of gravel trap in going on. Also, the steel lining works and concreting has been completed at all three culverts.

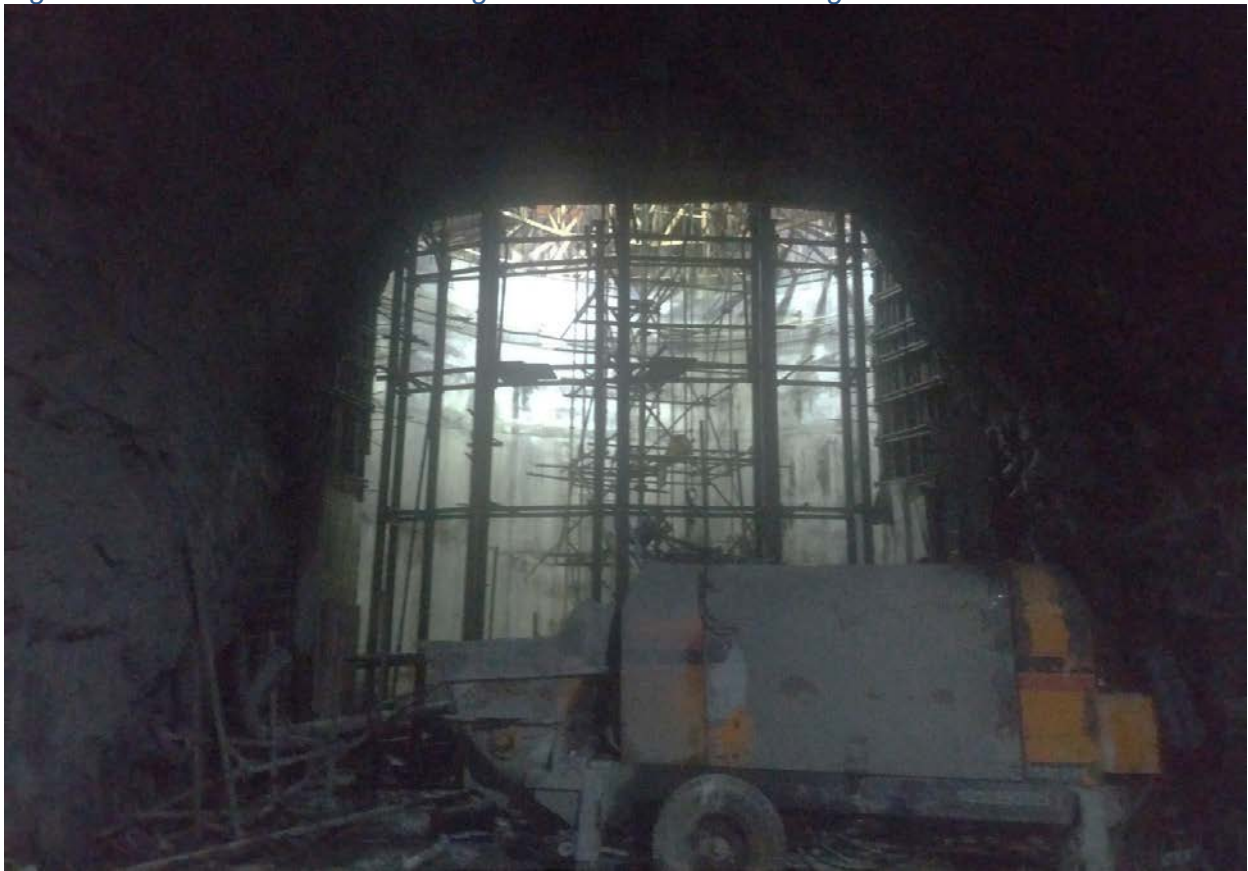
Figure 2-25: Concreting of surge shaft walls

The excavation for the widening works of Surge shaft to its design diameter of 16.4 m has already been completed up to the entire depth of 79.93 m from the top level of the crown. The installation of supports of 6 m long, 32 mm dia. rock bolt and 75 mm thick steel fiber shotcrete has already been completed. The concreting works has already been completed at the base of the surge shaft whereas the contractor is carrying out the rebar installation works and concreting works at the side walls of the surge shaft up to an elevation of 857 amsl which is about 11 meters from the invert.

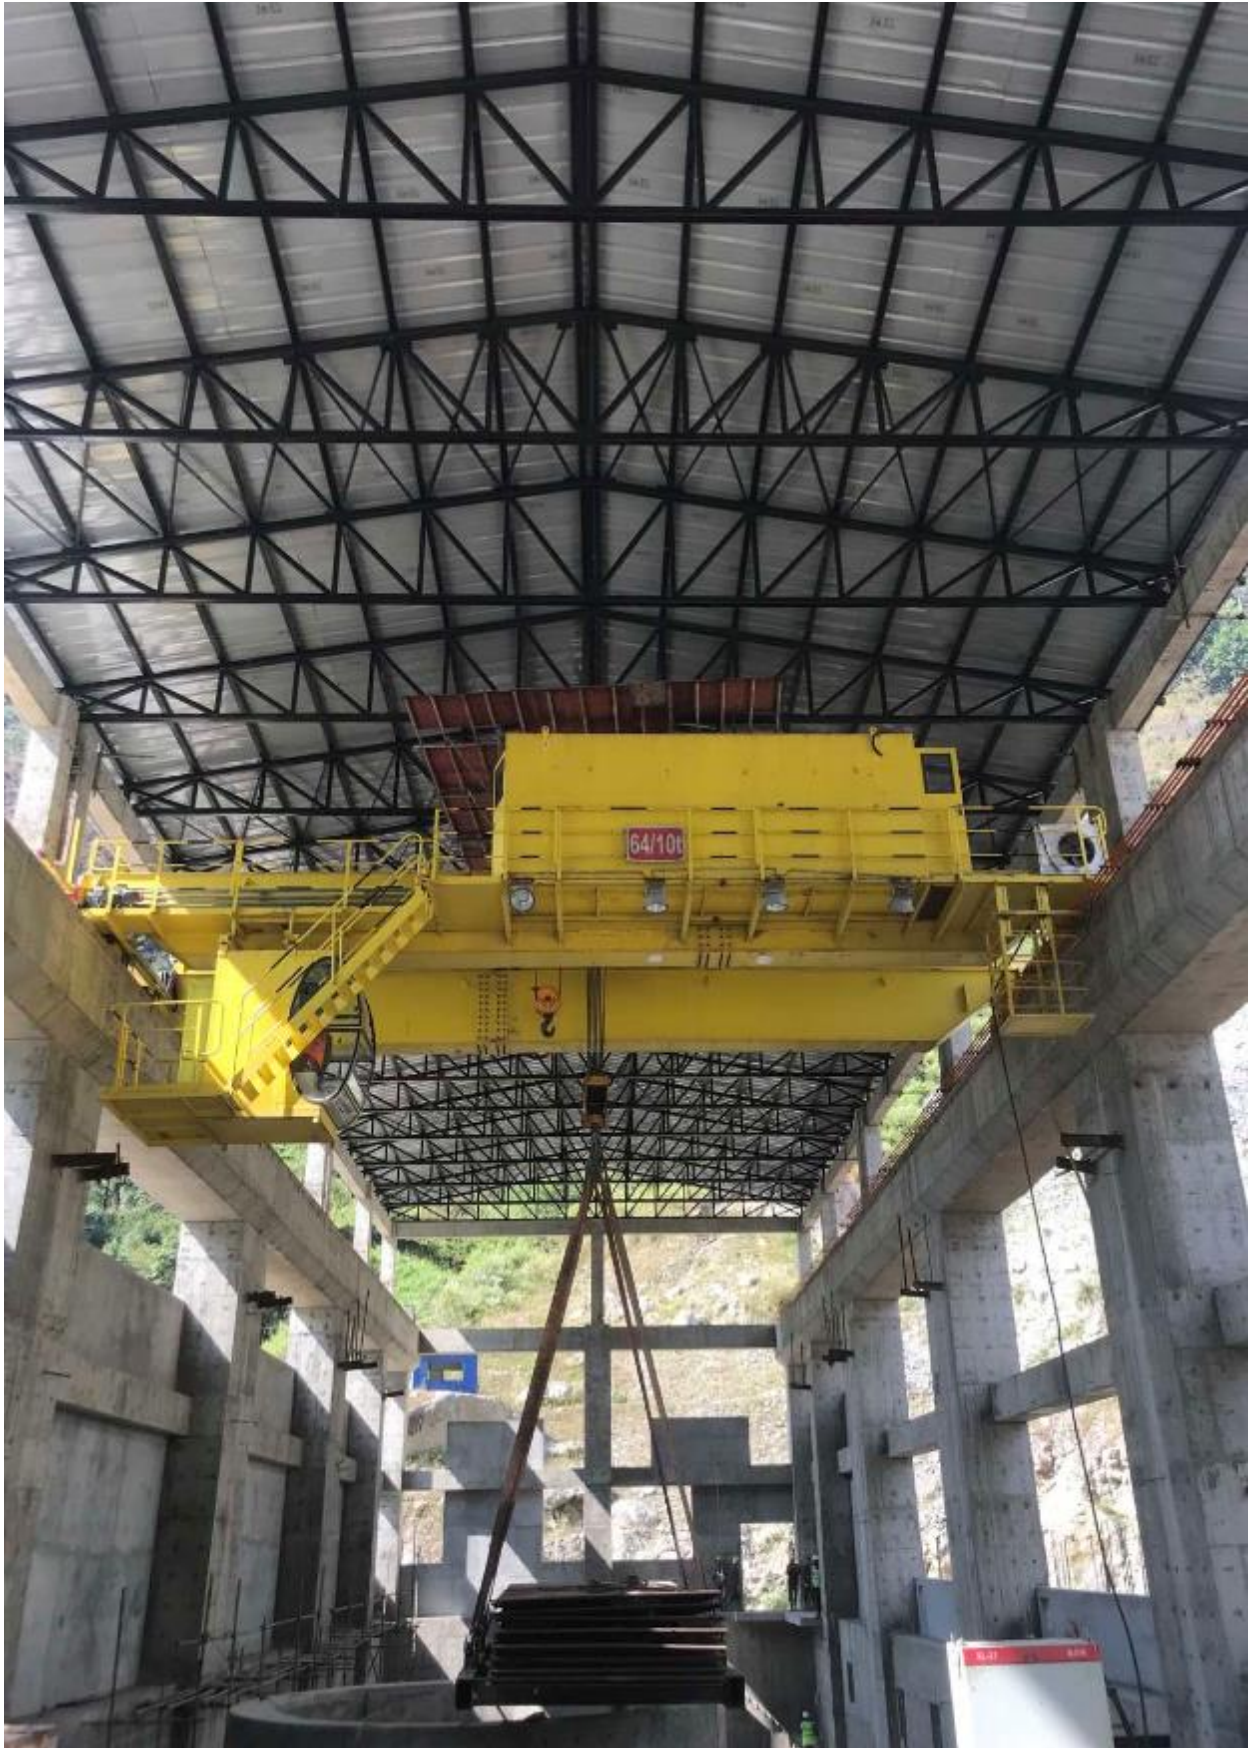
Figure 2-44: Load test of EOT lifting 66 ton and travelling across unit 2

After the completion of roofing in Bay 1 – electrical commissioning of the crane had been carried out. The crane was driven from bay 1 to bay 5 at various speed levels, safety & connections were checked accordingly. In order to verify the load capacity of EOT, load test of EOT crane was successfully carried out on November 07, 2022 by lifting 66 tons of dummy load.

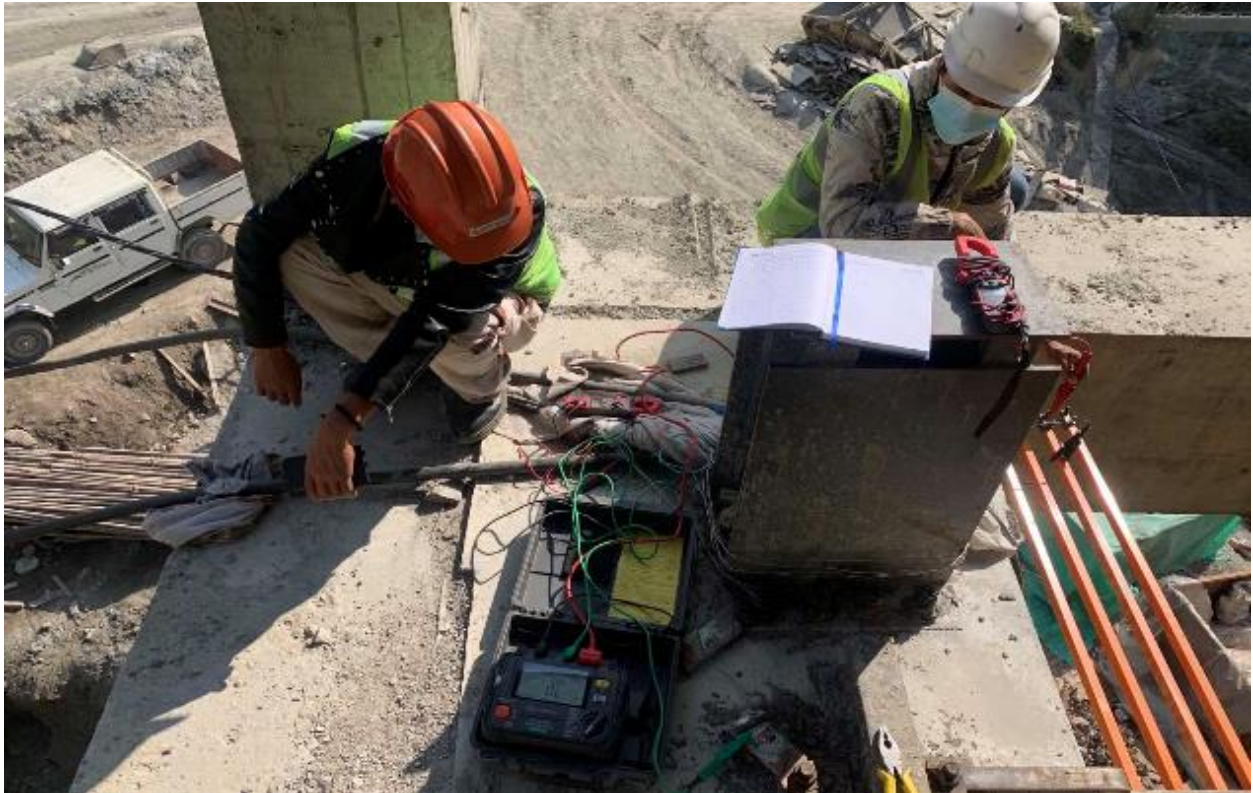
Figure 2-45: Insulation Resistance of EOT's busbar

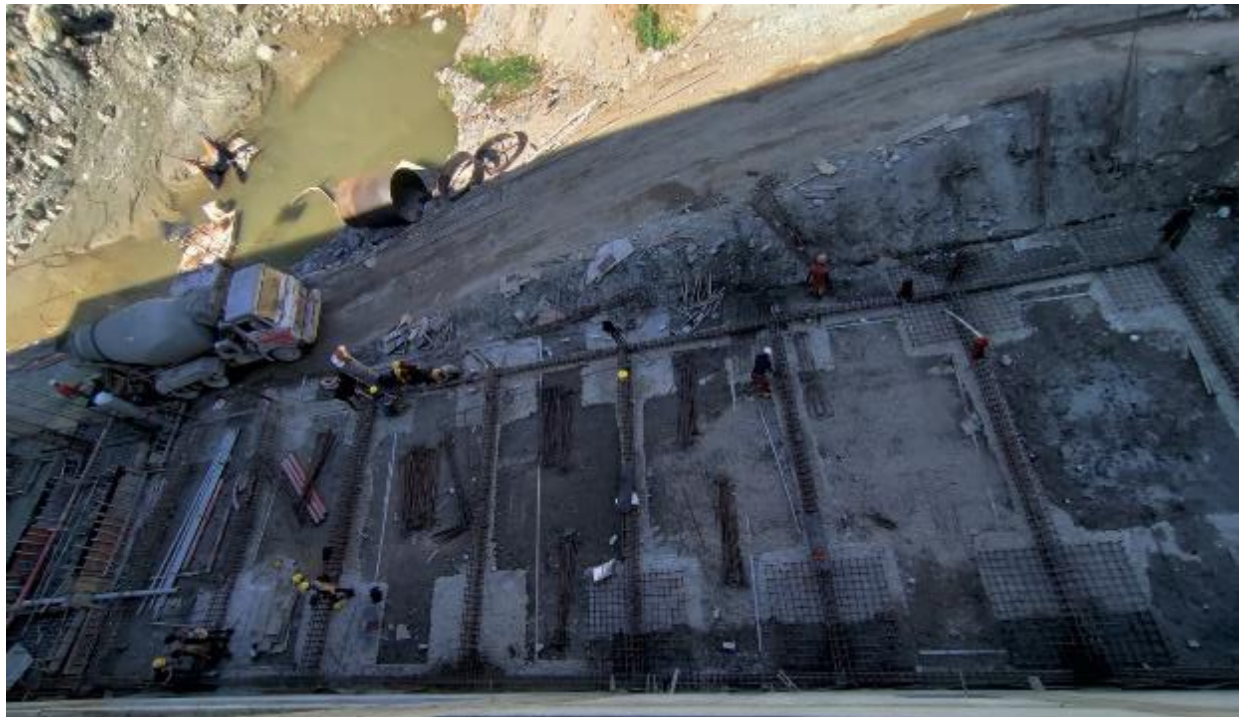
Figure 46: PCC done after earth mat installtion in auxiliary power house

After the Main Civil Contractor started the foundation of auxiliary power house, the EM contractor in close coordination – placed earth mat before the foundation. The Contractor placed various electrical power supply conduits, CCTV outlets, sensor pipe outlets, lighting system's conduit and emergency lighting system's conduits.

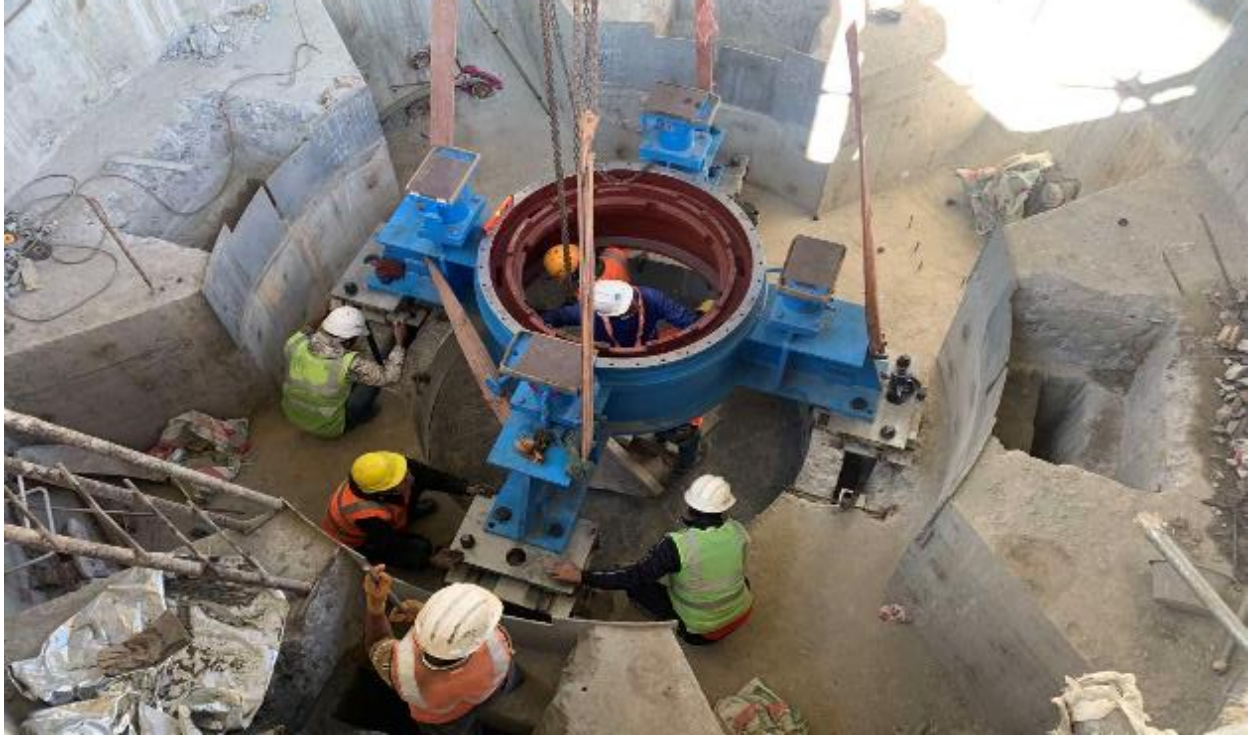
Figure 2-46: Installation of lower bracket in unit 1

Till date, the distributor segment comprising the bottom ring, guide vanes and head cover have been installed maintaining the line level. Further, the lower bracket for unit 01 generator has also been installed. Along with this, the stator has been lowered into the pit maintaining the level and co axial centre with the turbine accessories. Similarly, the preparation of electrical on site test of stator winding bar and rotor assembly in the service bay is being carried out.

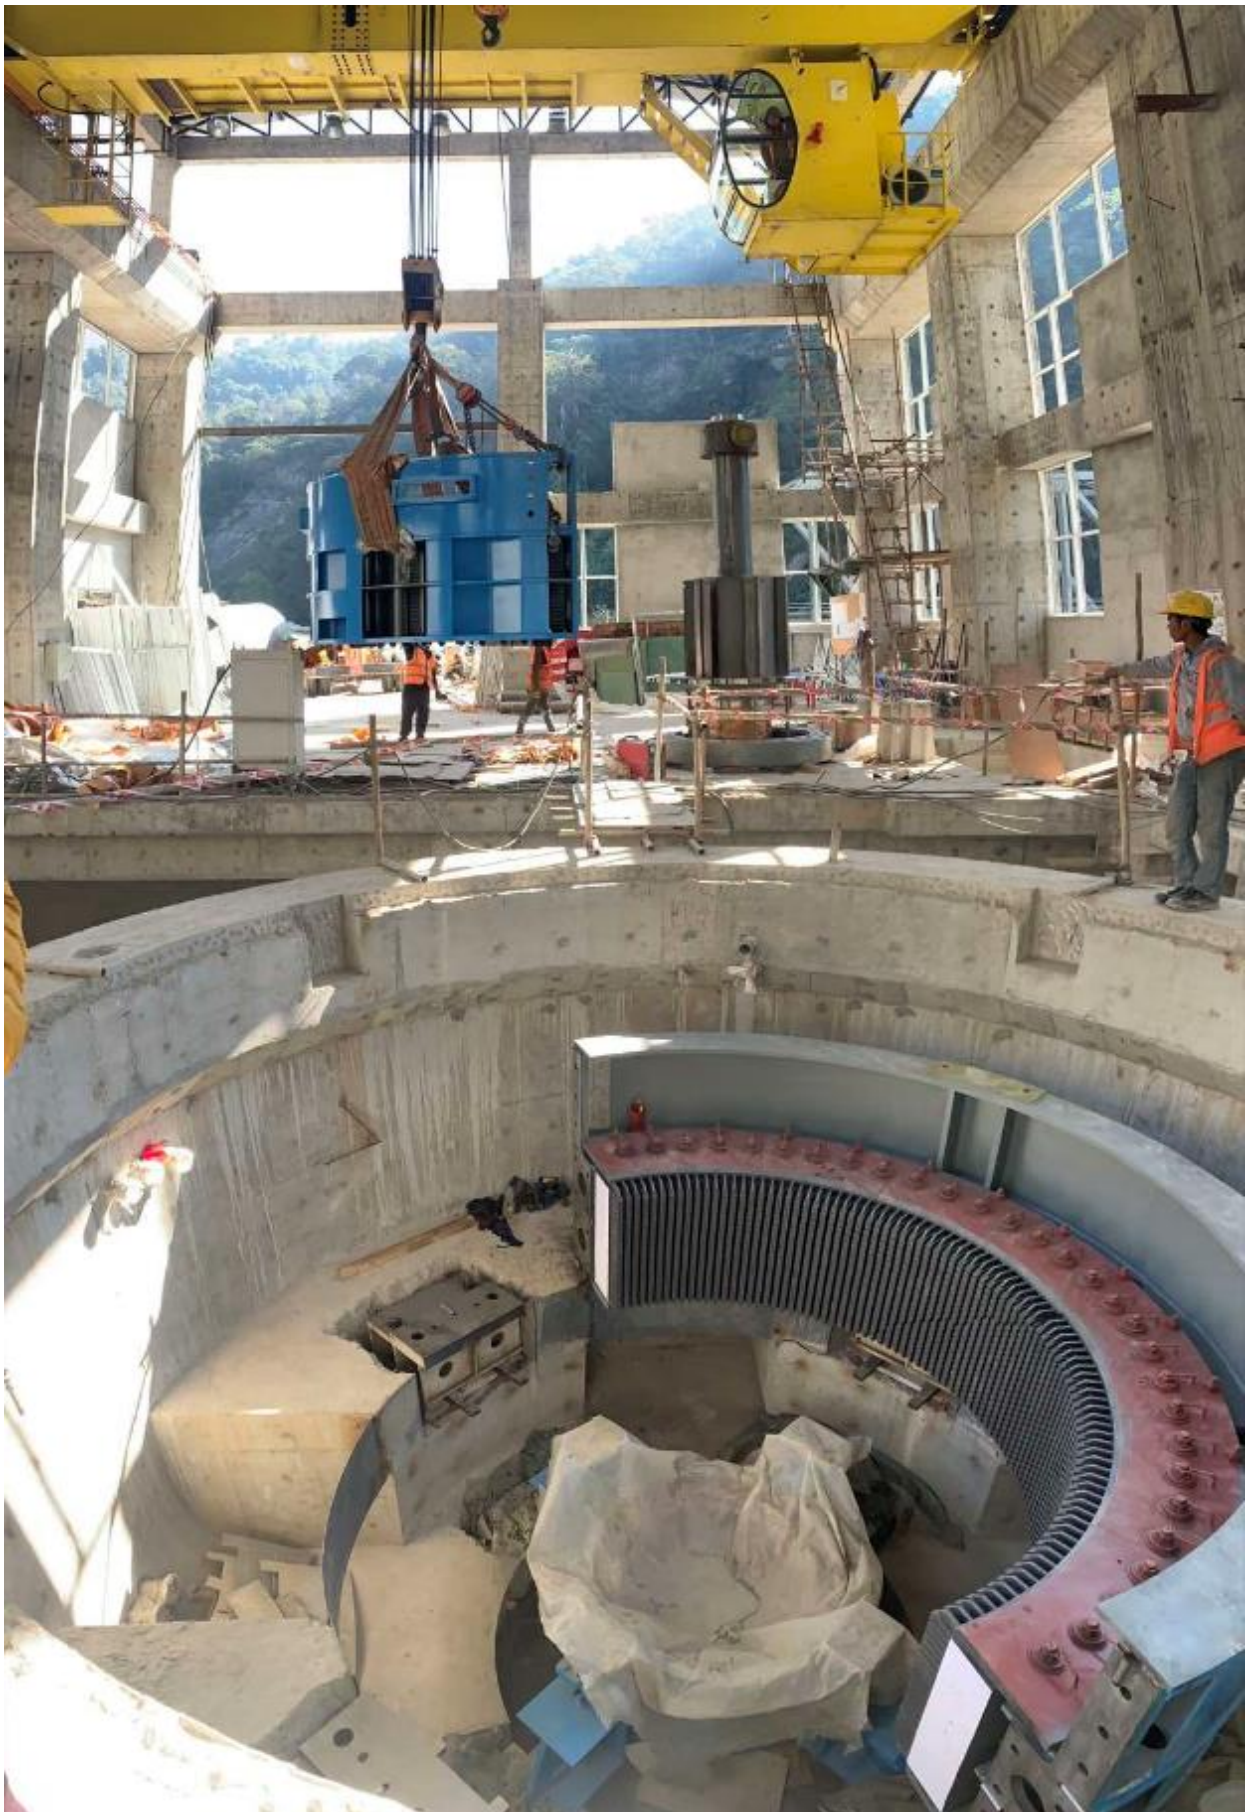
Figure 2-49: Lowering of stator into unit pit 1

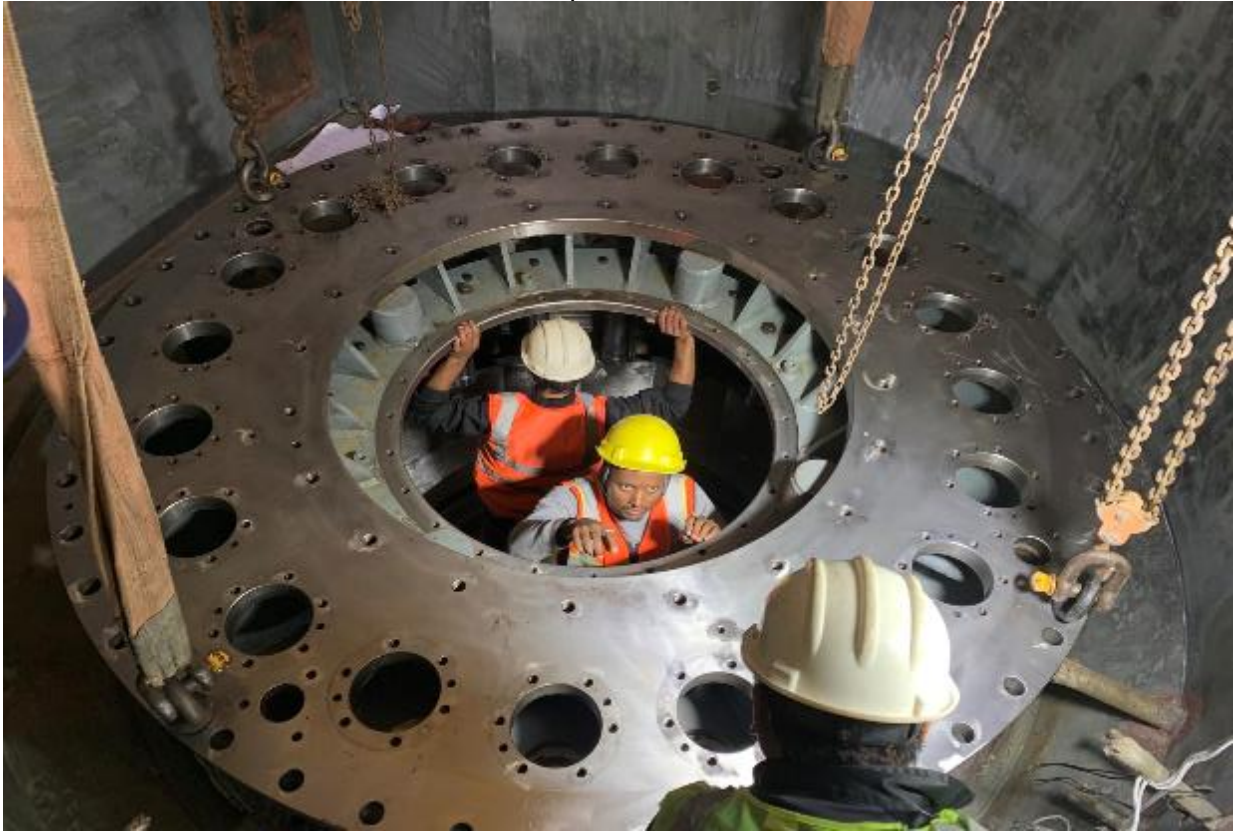
Figure 47: Lowering of headcover in unit 2

Till date, the distributor segment including bottom ring, guide vane with its guide vane sleeve and head cover have been installed maintaining the line level. Further, necessary preparation is being carried out to install lower bracket in unit 02 pit.

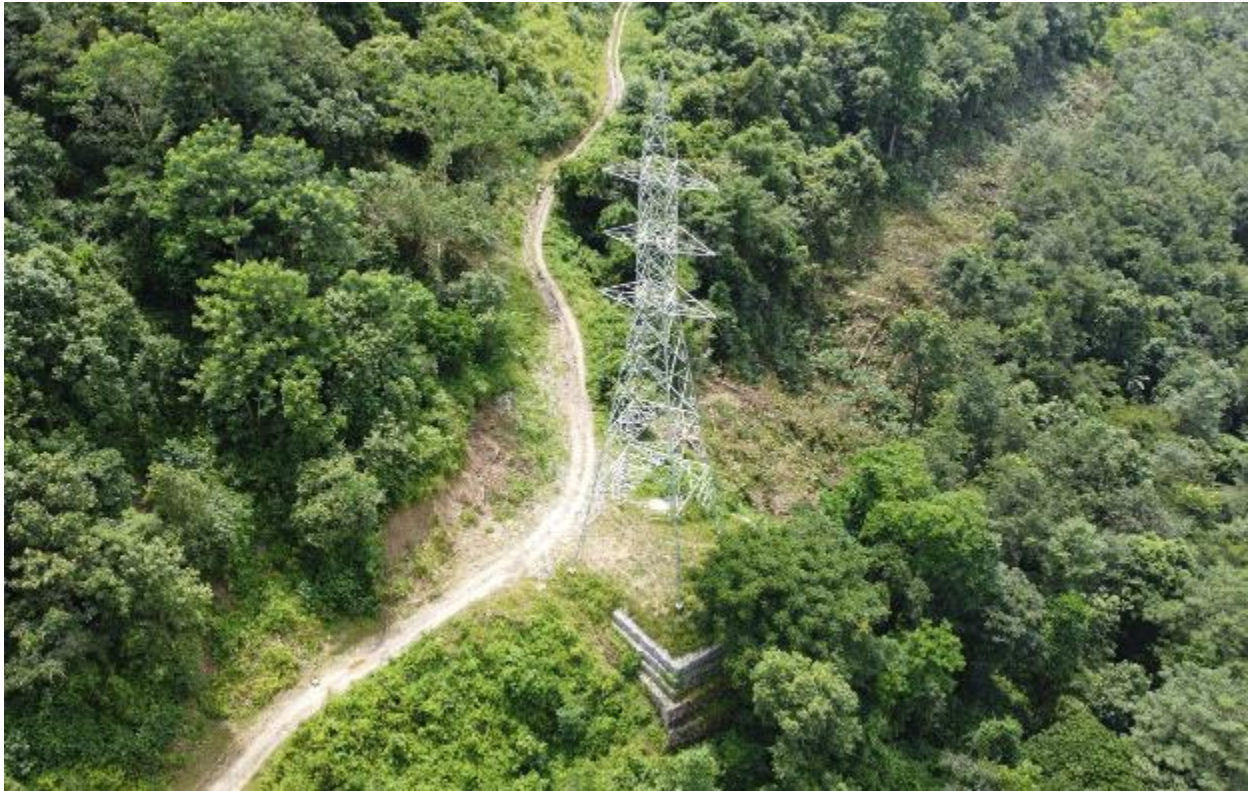
Figure 2-54: A view of AP10 along with protection works
