MIDDLE TAMOR HYDROPOWER PROJECT (73 MW)

PROGRESS REPORT

(March 2023)

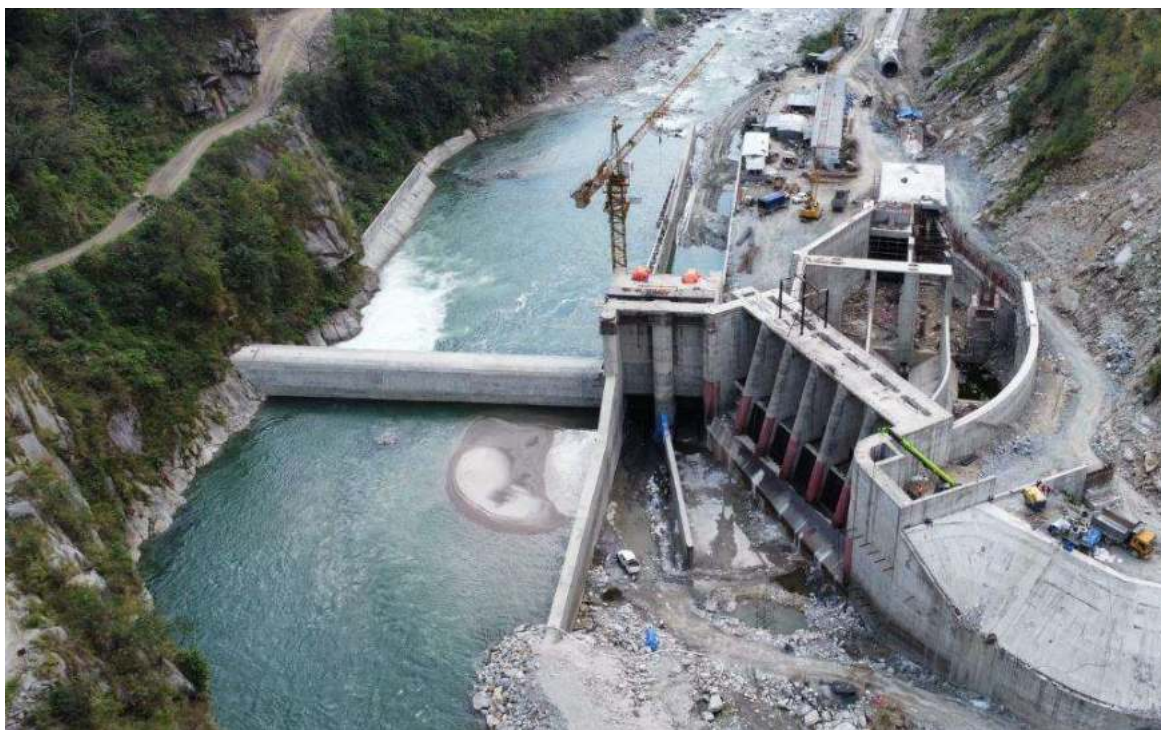
Figure 2-7: Aerial view of headworks from upstream

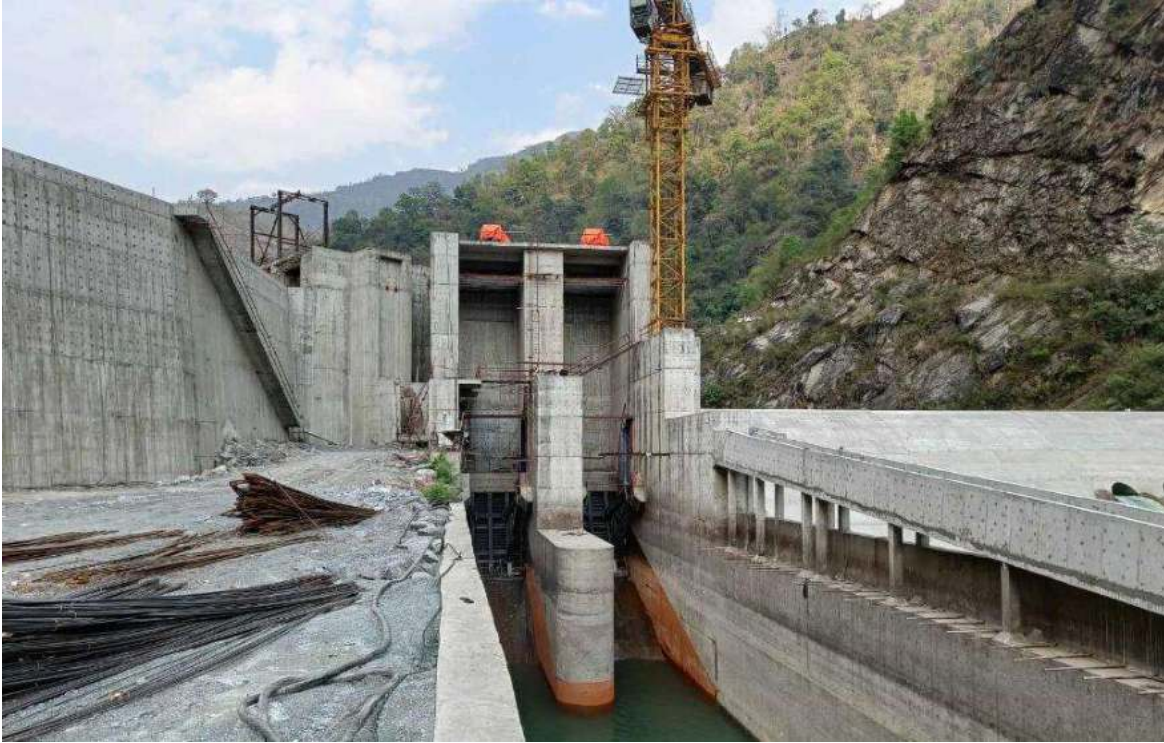
The construction of undersluice has been completed as of February 2023 along with the construction of the fish ladder. About 19,327 m³ of concrete was poured in the Undersluice portion till the completion.

Figure 2-8: Gate installation works at undersluice

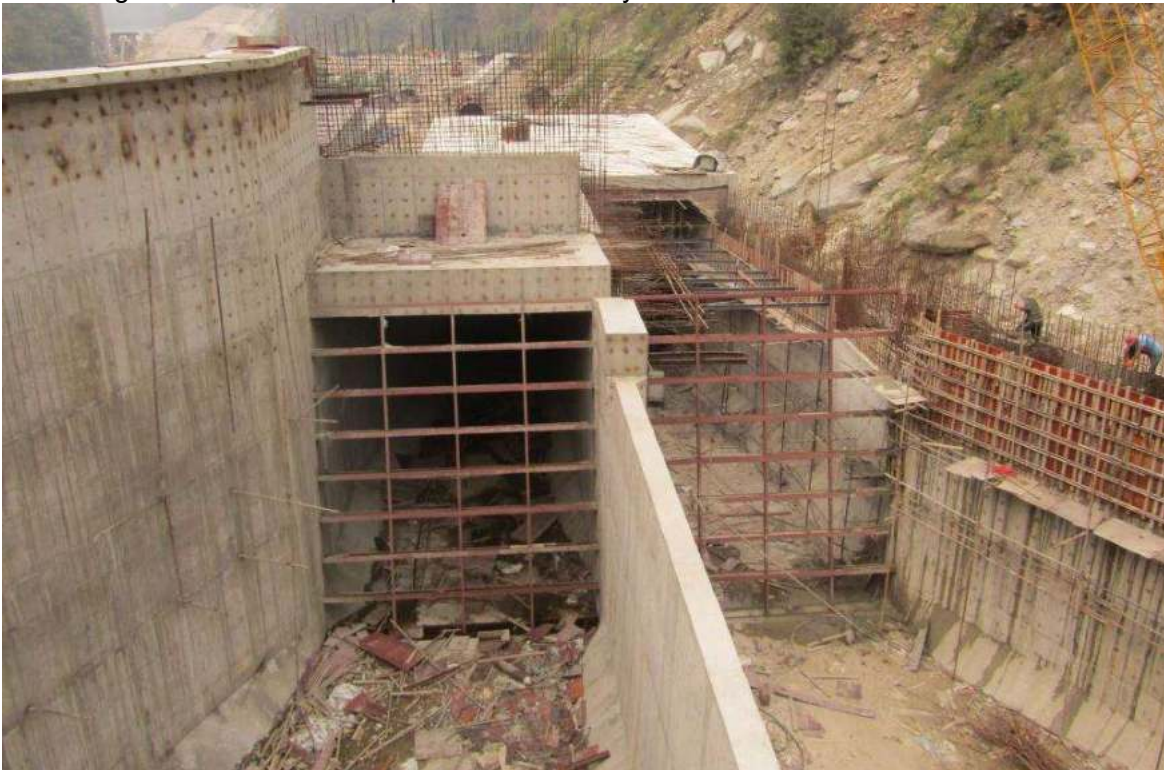
Till date, about 7,571.71 m³ of concrete has been poured at the conveyance tank region. The concreting works at the top slab and side walls of the hill side panel is going on. Almost 94% of concreting works has been completed in the conveyance tank section.

Figure 2-9: Concreting of conveyance tank nearing completion

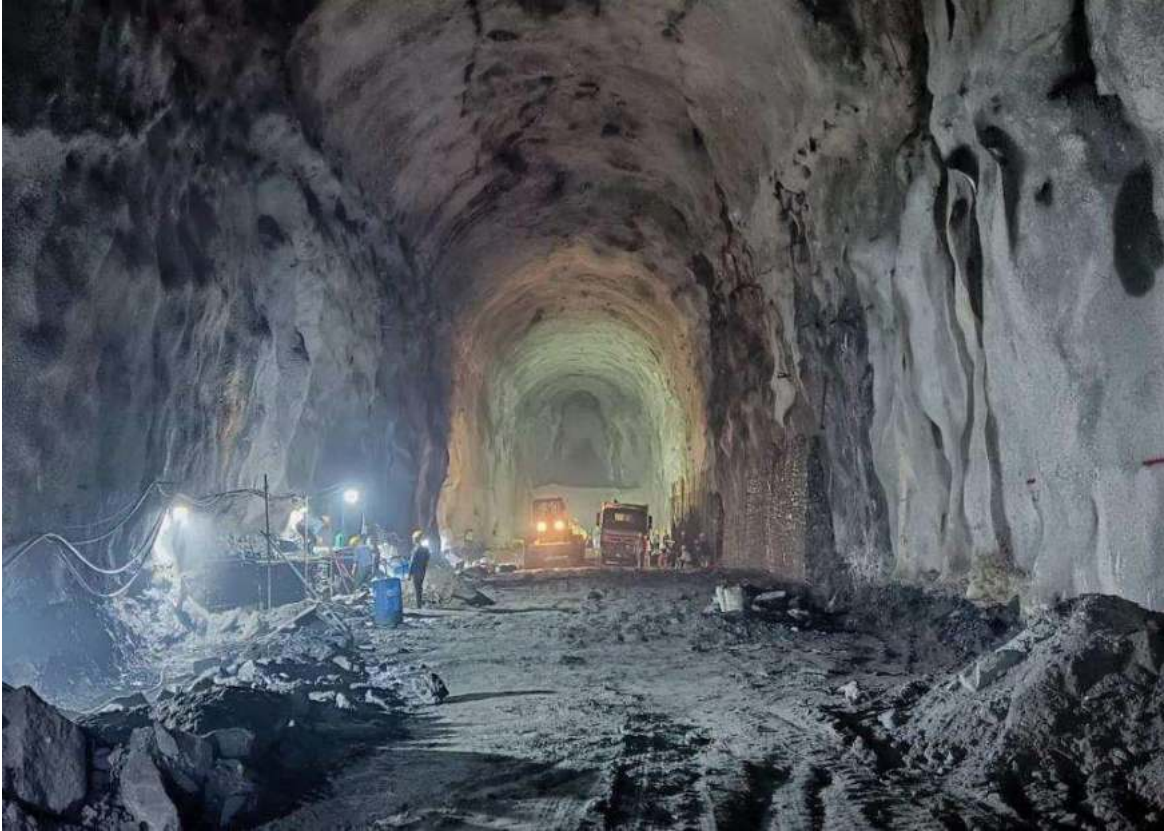
settling basin bay 01 has been completed as of February 2023. Till date almost 29,669.13 m³ excavation has been carried out in SB-01. The Contractor is planning for the concrete lining works at this section.

Figure 2-11: A view of stone masonry works at Settling basin 01

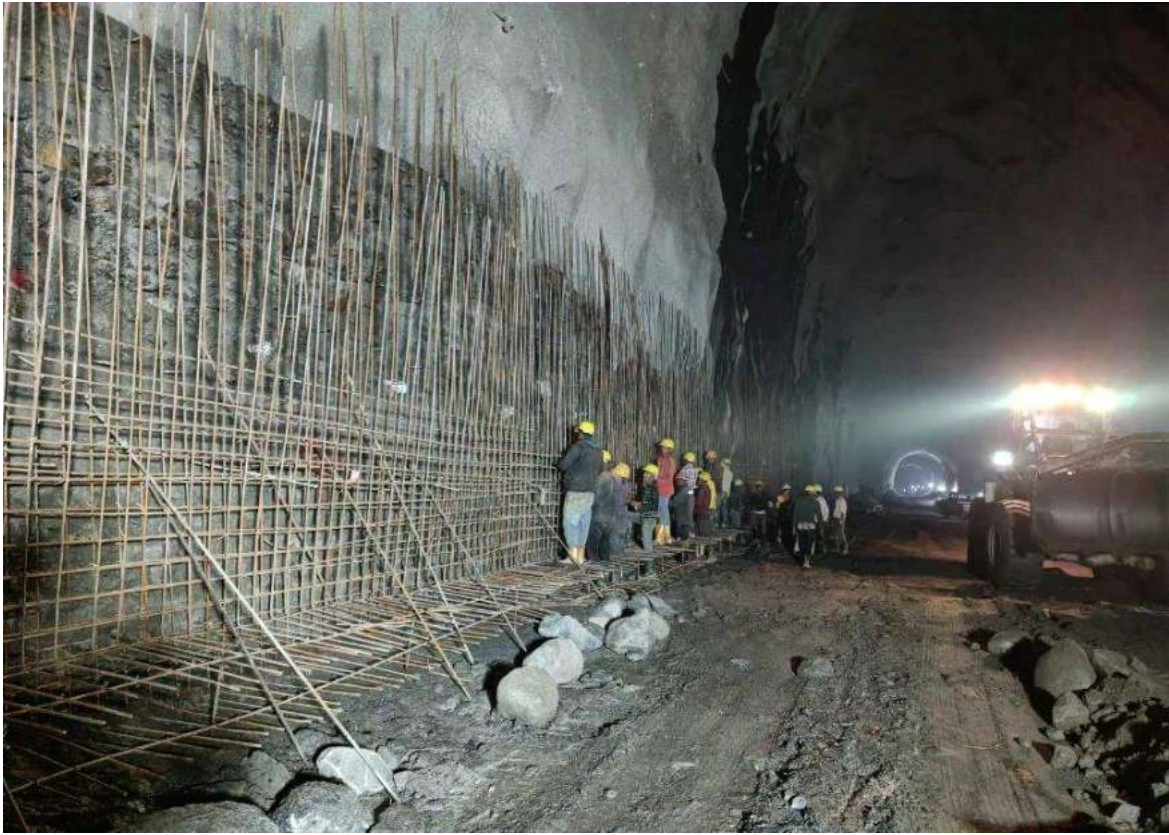
Figure 2-12: Rebar layout at right wall of settling basin 01

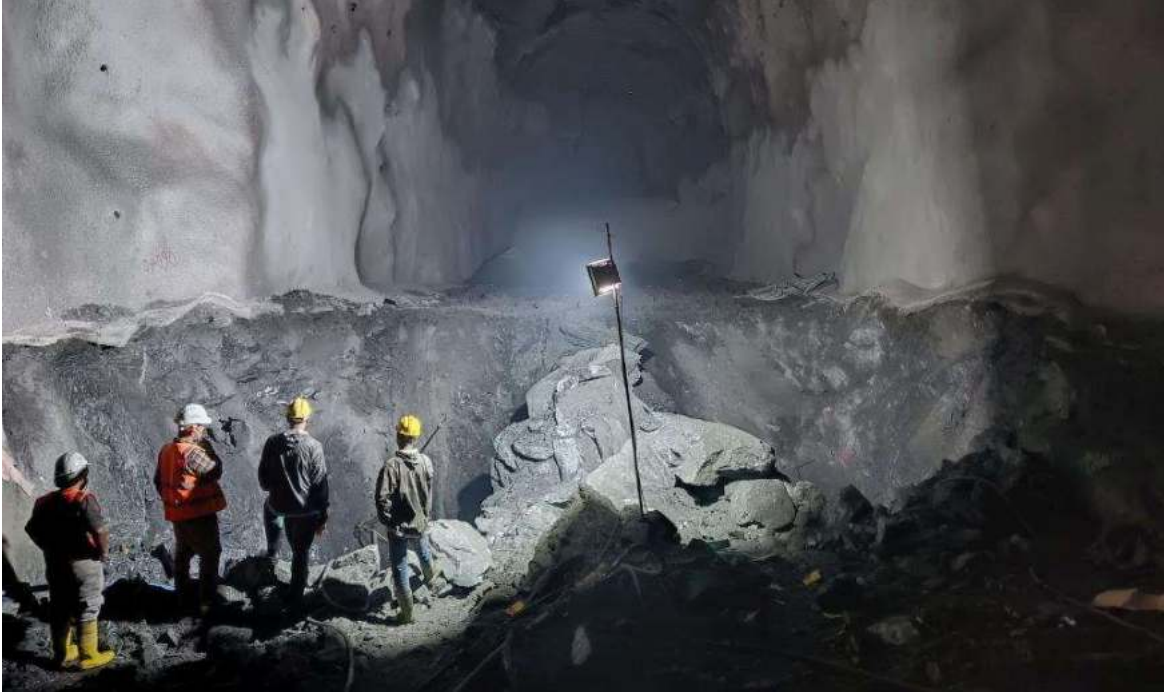
The settling basin bay 02 is 100 m long along with 35 m long inlet transition zone and 15 m long outlet transition zone. The settling basin bay is 13.5 m wide and 17.5 m high. The Contractor is carrying out the application of supports at the crown. The Contractor has already carried out the excavation up to the sill of hooper and is currently excavating the hooper of bay 02. Till date almost 28,376 m³ excavation has been carried out in SB-02. This is about 96% volumetric excavation progress at SB-02.

Figure 2-13: Excavation of hooper face

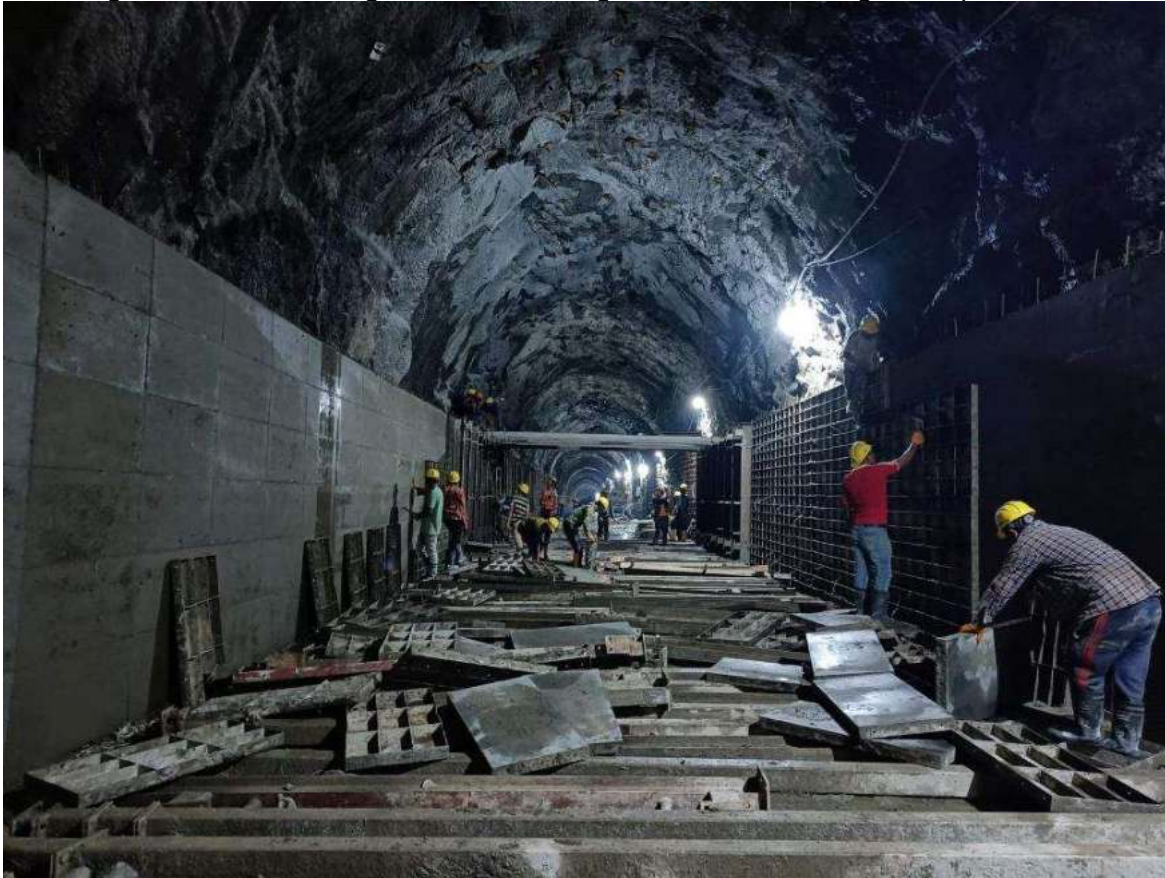
In addition to this, the Contractor has already carried out the concrete wall lining works at the HRT walls for about 1,735 meters out of 3,367 meters. This is about 64% progress out of the total wall lining works. The full lining concrete shall begin once the wall lining is completed.

Figure 2-15: A section of HRT with concrete wal lining

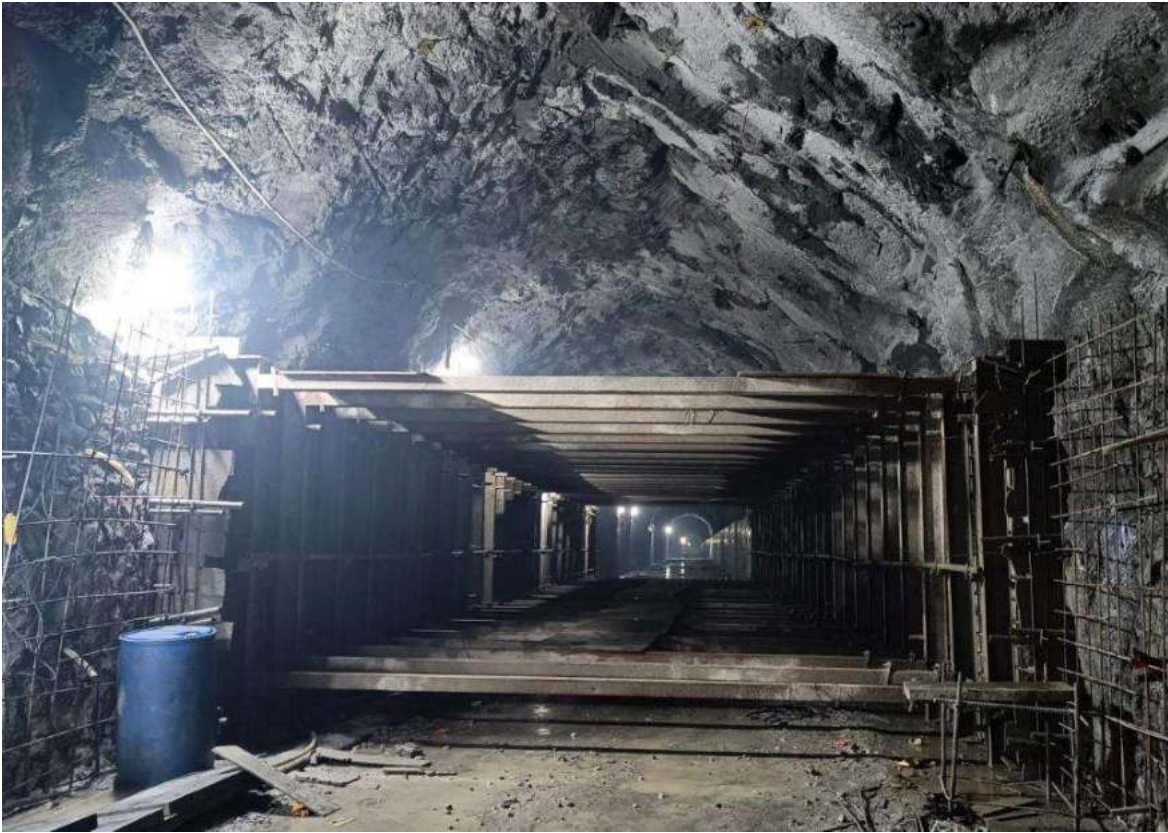
Figure 2-16: Preparation of formwork assembly for concrete wall lining at chainage 1+100

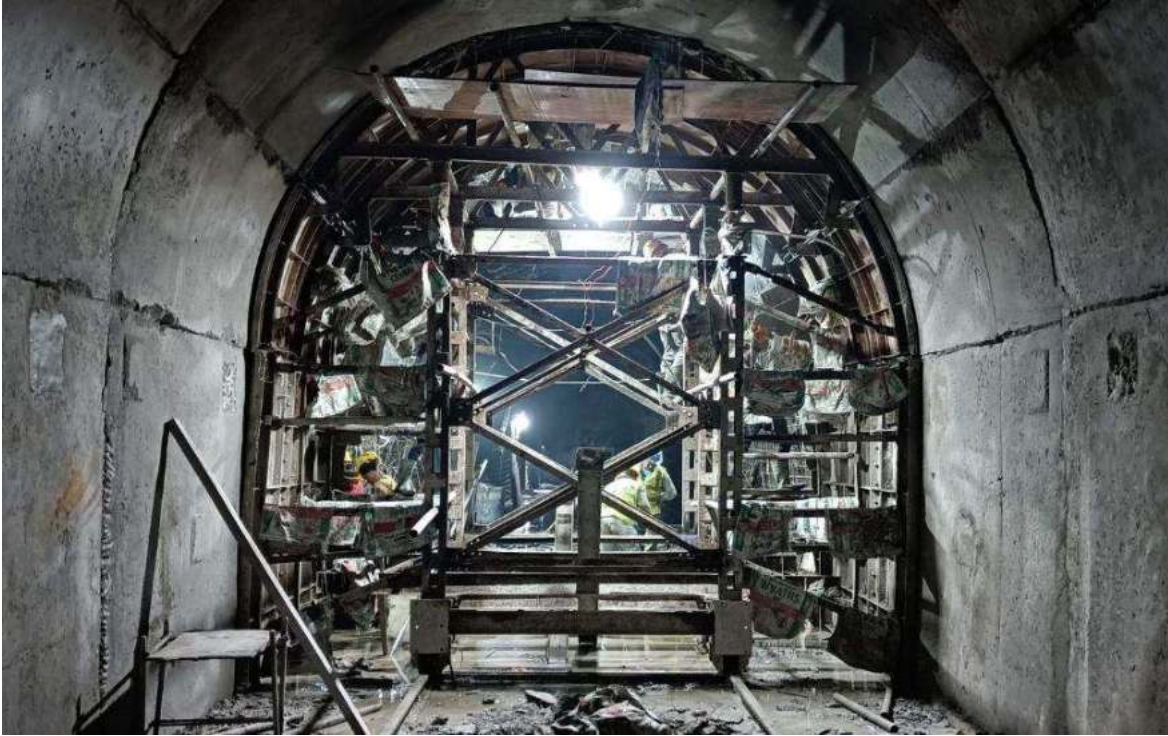
104.6 m progress by length has been achieved in the excavation of connecting tunnel-03. The rock support work with rock bolt installation and shotcreting is in progress. Further, the invert concreting has been completed and the concrete lining works is being carried out at the walls of the connecting tunnel 03.

Figure 2-20: Assembling of formwork for full concrete lining at connecting tunnel 03

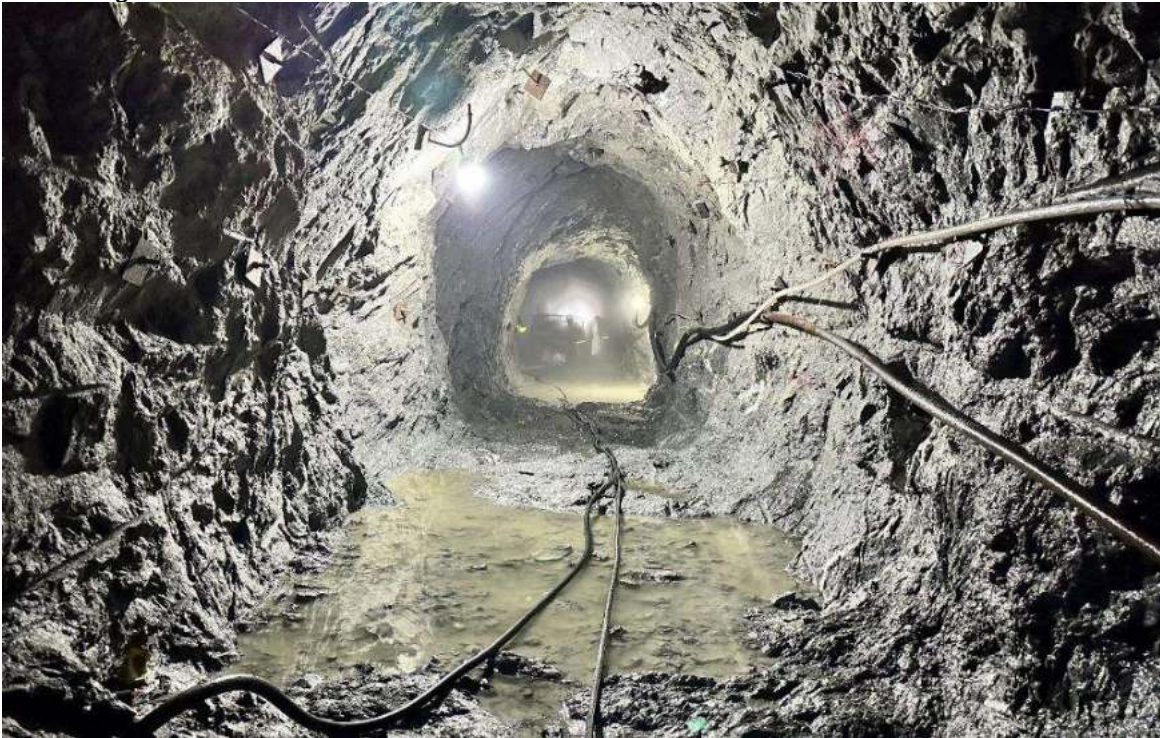
The excavation of 475 meters long sediment flushing tunnel has already been completed as of February 2023. The cleaning of the invert is being carried out before the commencement of the concreting works.

Figure 2-21: A view of invert cleaning works at the flushing tunnel

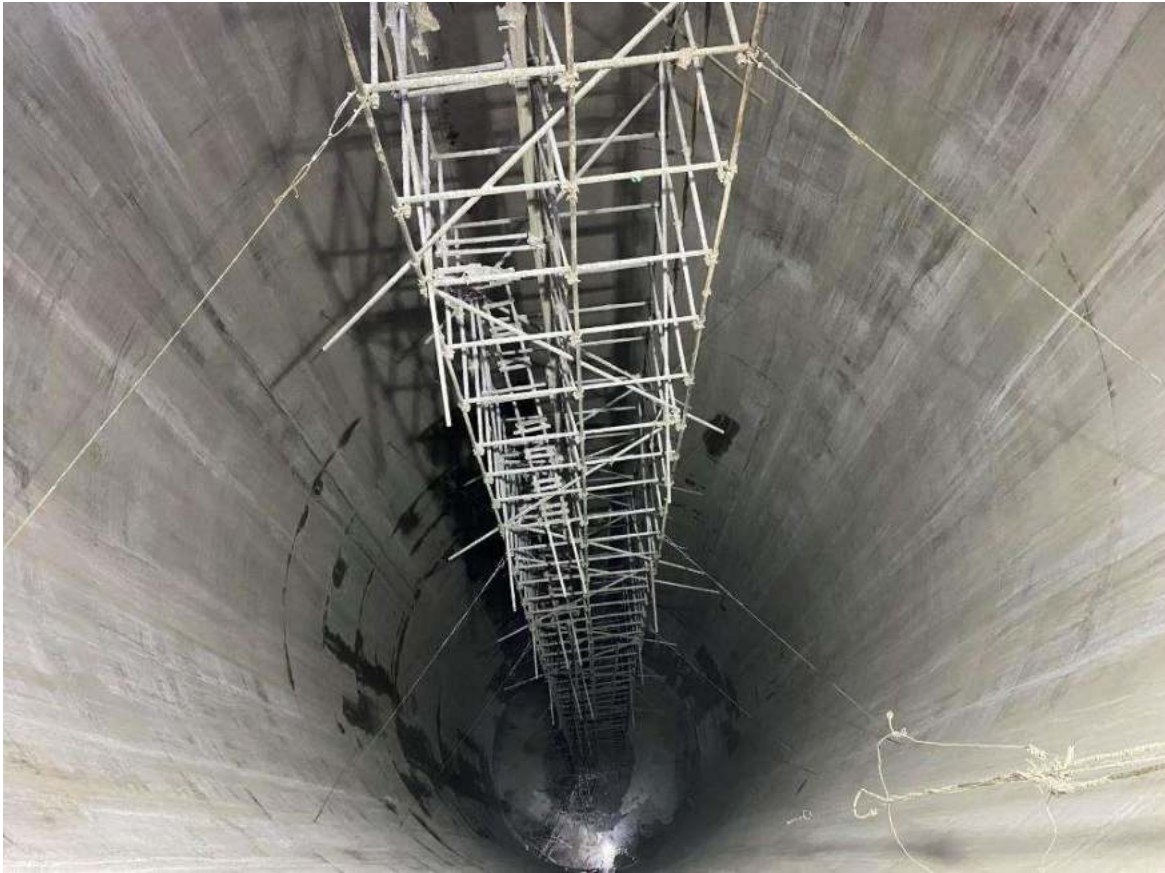
The excavation for the widening works of Surge shaft to its design diameter of 16.4 m was completed up to the entire depth of 79.93 m from the top level of the crown. The installation of supports of 6 m long, 32 mm dia. rock bolt and 75 mm thick steel fiber shotcrete has already been completed. The concreting works also has been completed as of January 31, 2023.

Figure 2-22: A view of surge shaft (Concrete lining completed)

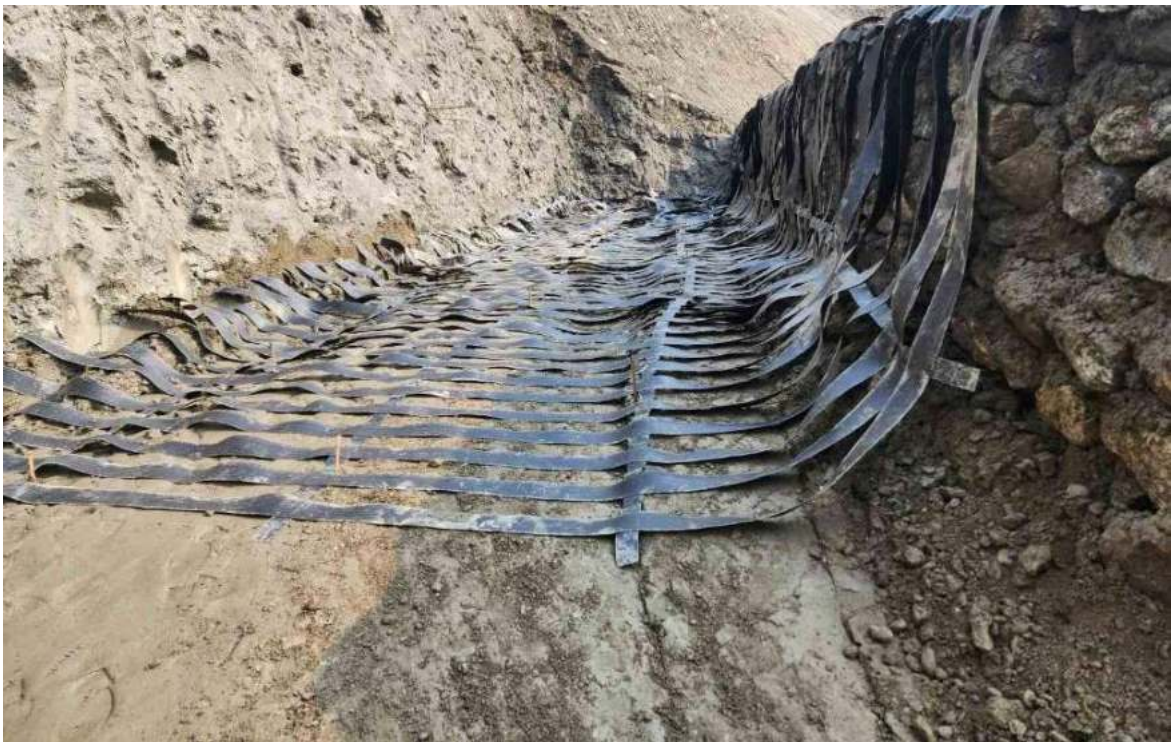
Figure 2-29: Penstock slope stablization using geogrid (paralink)

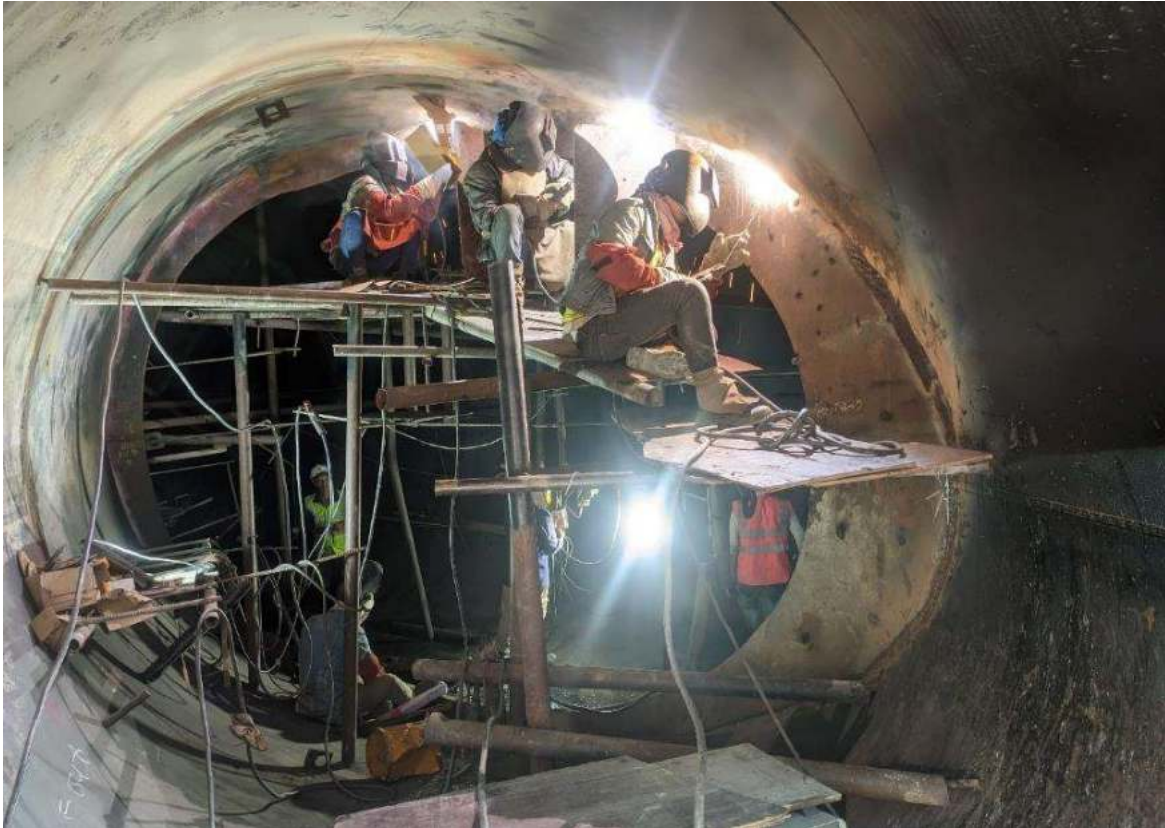
Figure 2-39: Welding work at sickle plate of bifurcation 01

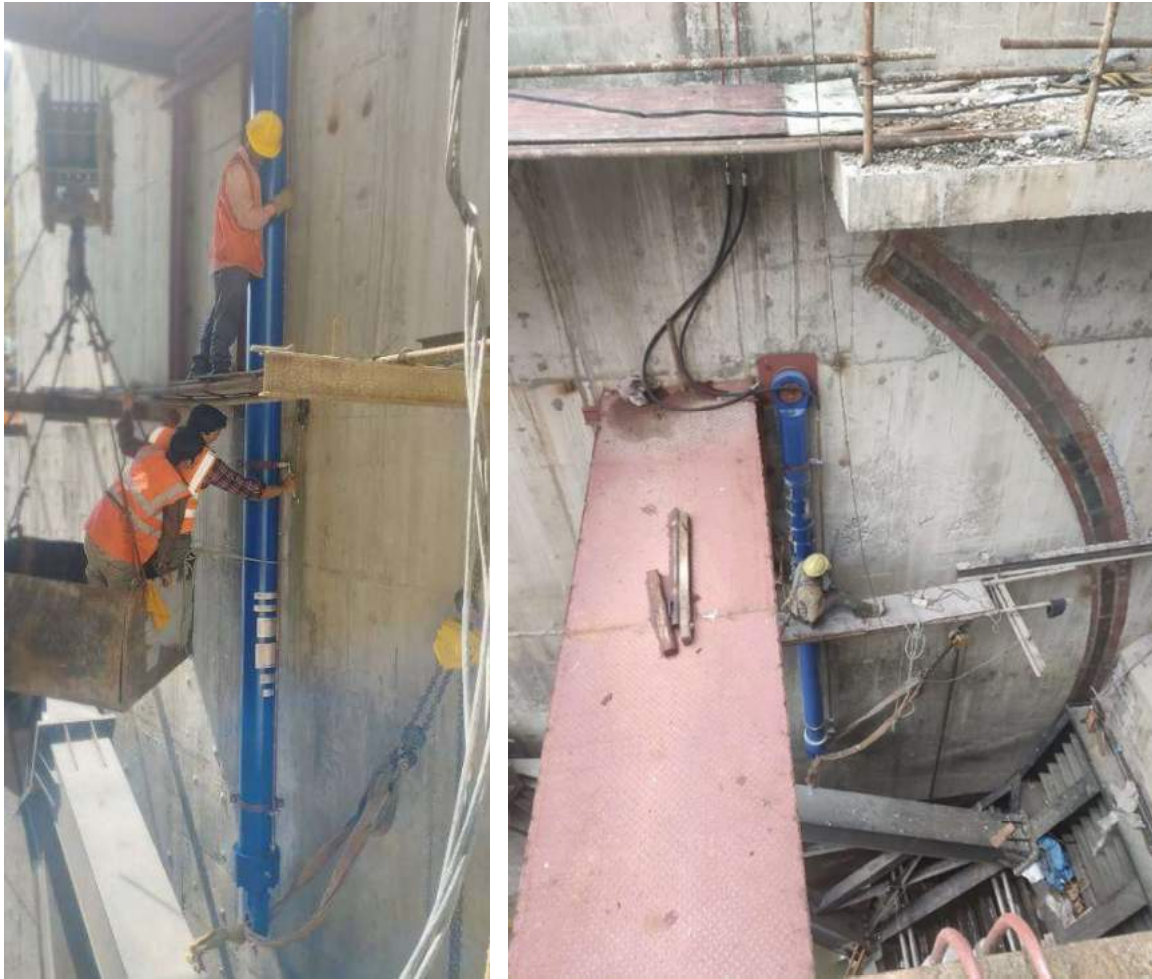
Figure 2-43: Erection of hydraulic hoisting cylinders of radial gate (left) and hydraulic arm of radial gate of intake side (right)

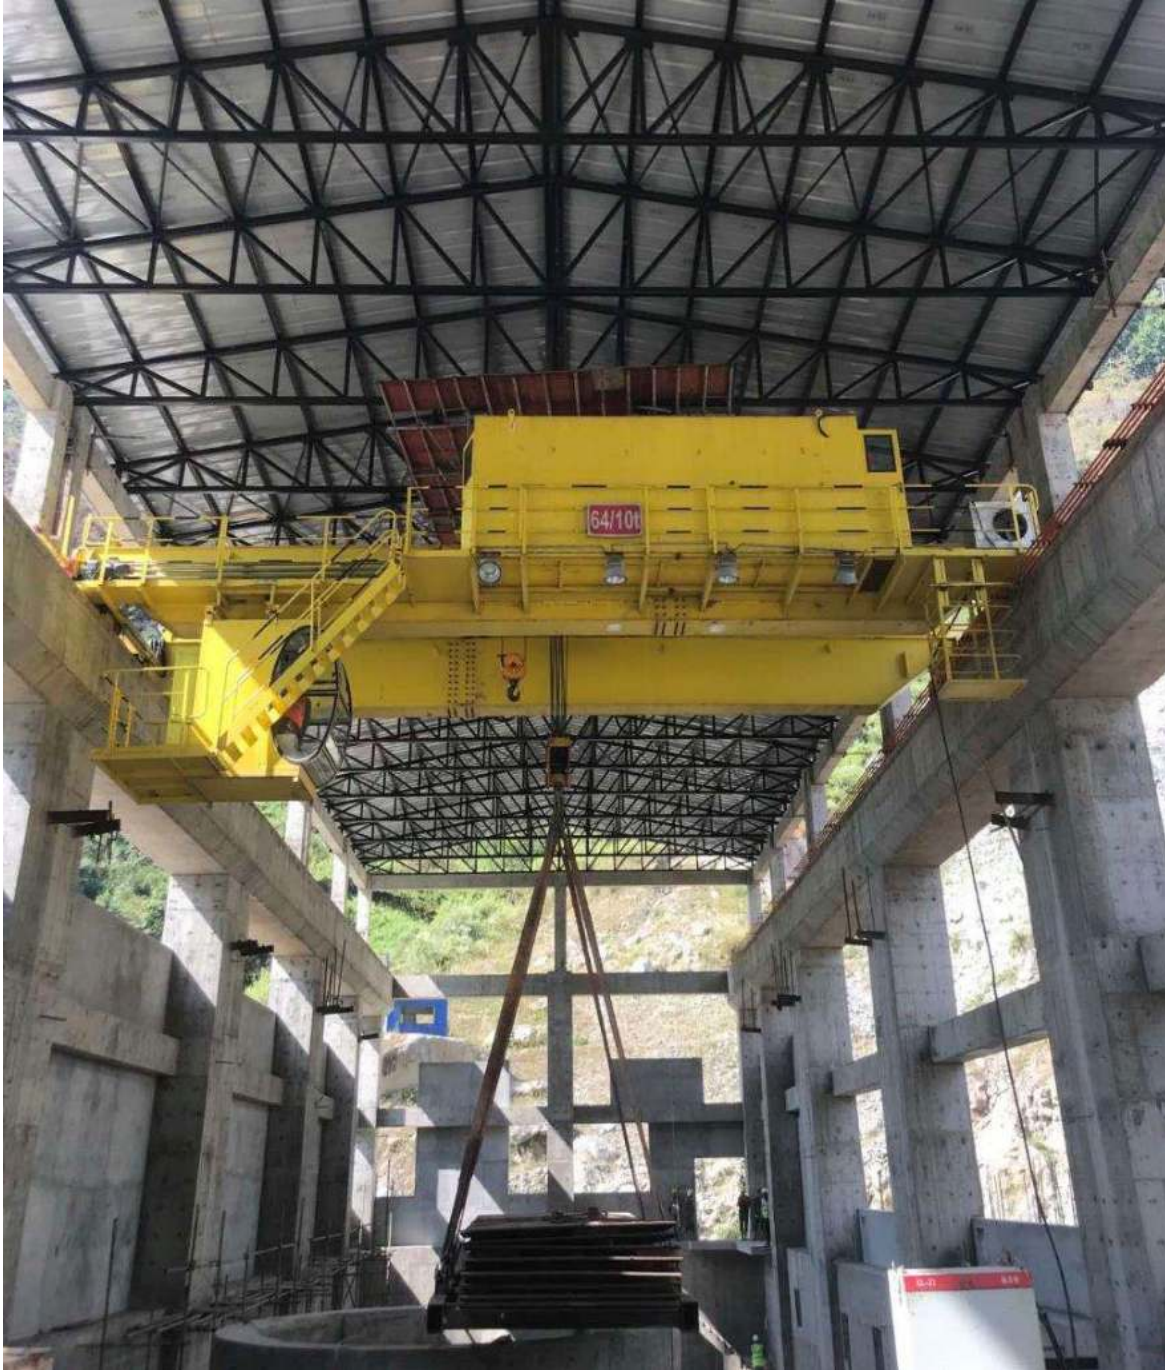
After the completion of roofing in Bay 1 – electrical commissioning of the crane had been carried out. The crane was driven from bay 1 to bay 5 at various speed levels, safety & connections were checked accordingly. In order to verify the load capacity of EOT, load test of EOT crane was carried out by lifting 66 TON of dummy load successfully. Few photos showing the proceedings of load test are shown below:

Figure 2-53: Load test of EOT lifting 66 ton and travelling across unit 2

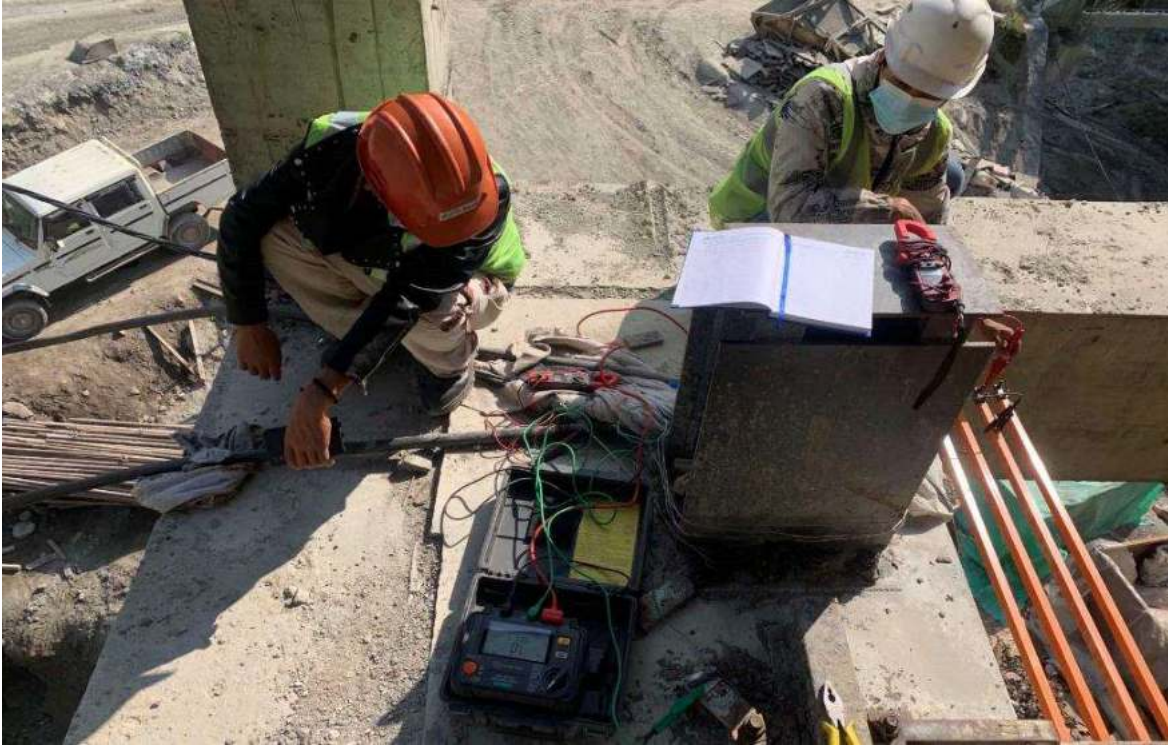
Figure 2-54: Insulation Resistance of EOT's busbar

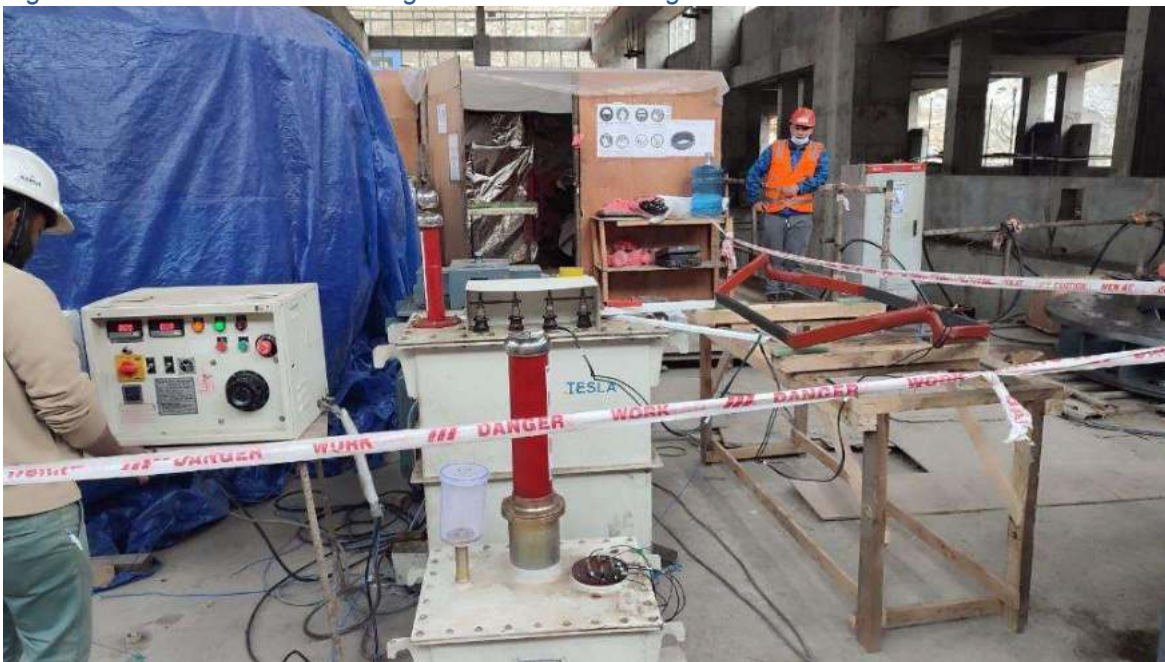
Figure 2-57: High voltage test of stator coil

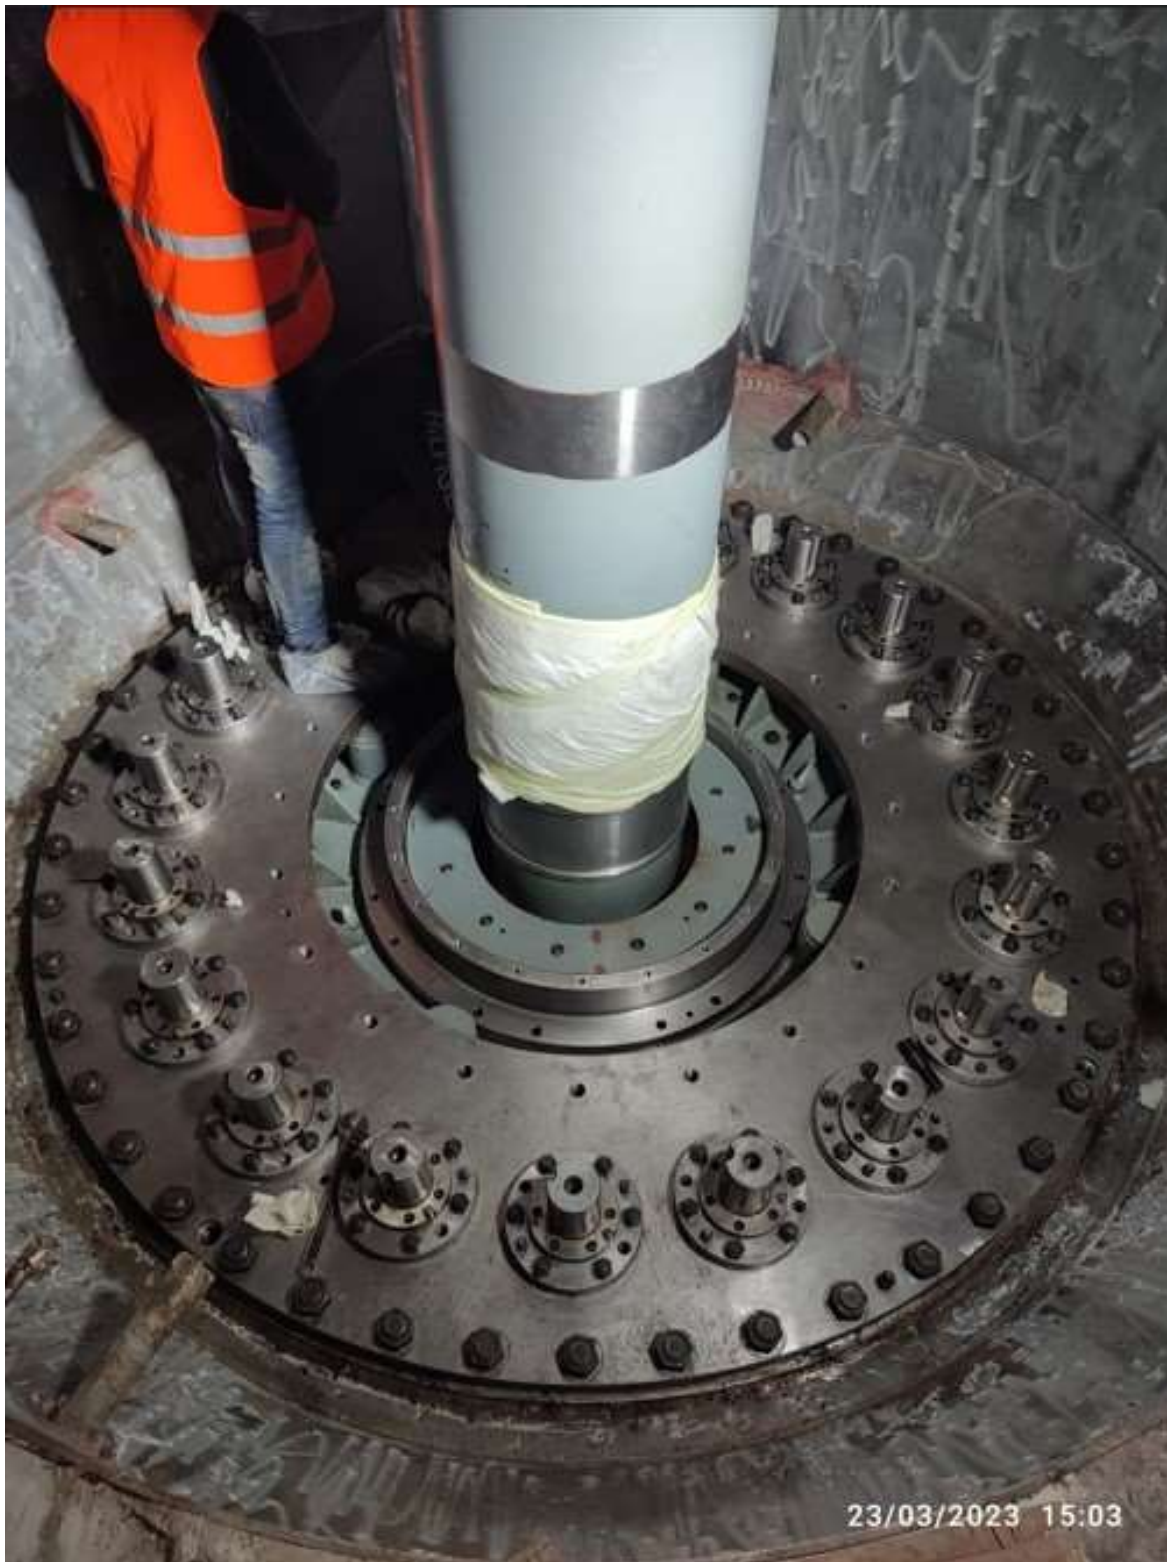
The final assembly of bottom ring, guide vane, main shaft with runner, head cover and air cooler has been completed, while the lower bracket, split stator parts and upper bracket have been lowered and preassembled. Additionally, the rotor of unit one has been parked in unit two to facilitate the rotor assembly work of the next unit. Below few photographs are attached depicting the work progress.

Figure 2-60: Final assembly of bottom ring, guide vane, head cover and main shaft with runner

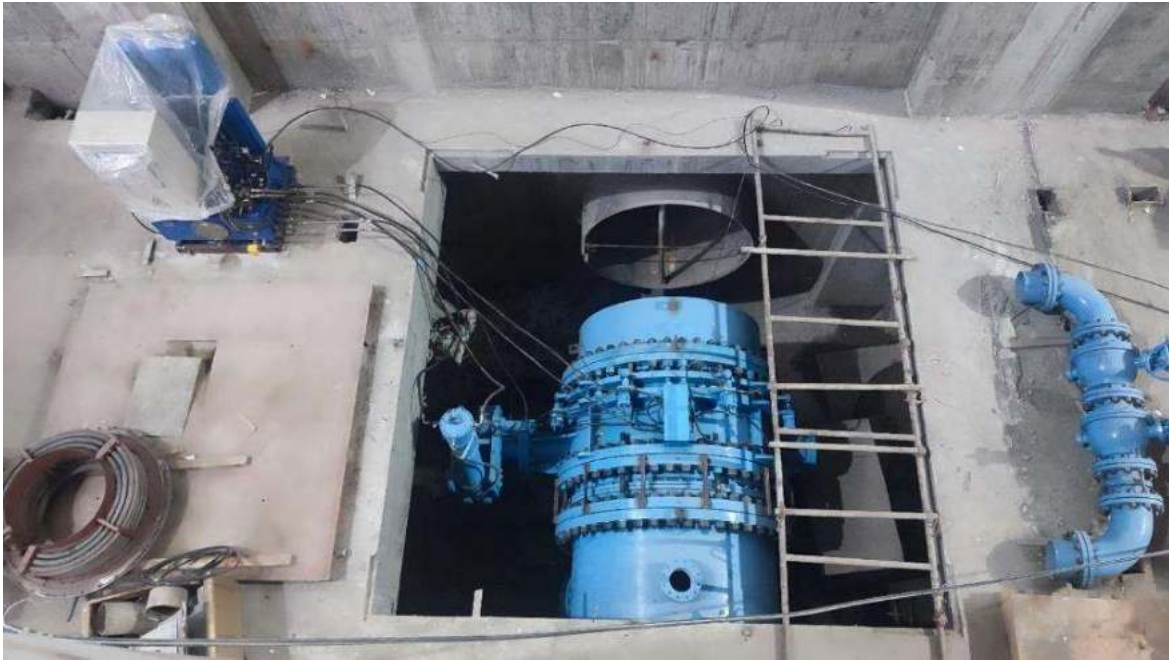
All 4 units of Main inlet valve have been successfully delivered to the site, and as of today, they have been lowered into their respective positions, with the downstream side welding of the unit 2 valve now completed. Few photographs of different stages of assembly of Main inlet valve are shown below:

Figure 2-69: Unit 4 MIV lowered to its position

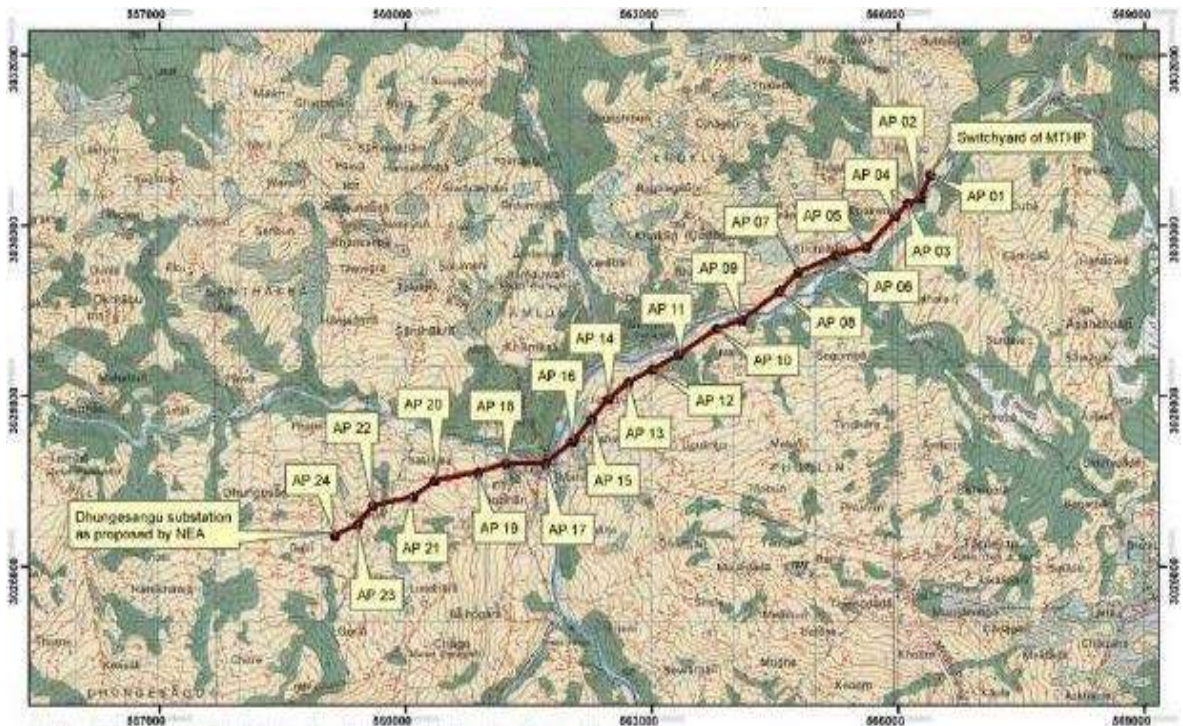
The transmission line route map is shown in figure below.

Figure 2-72: Transmission line route map

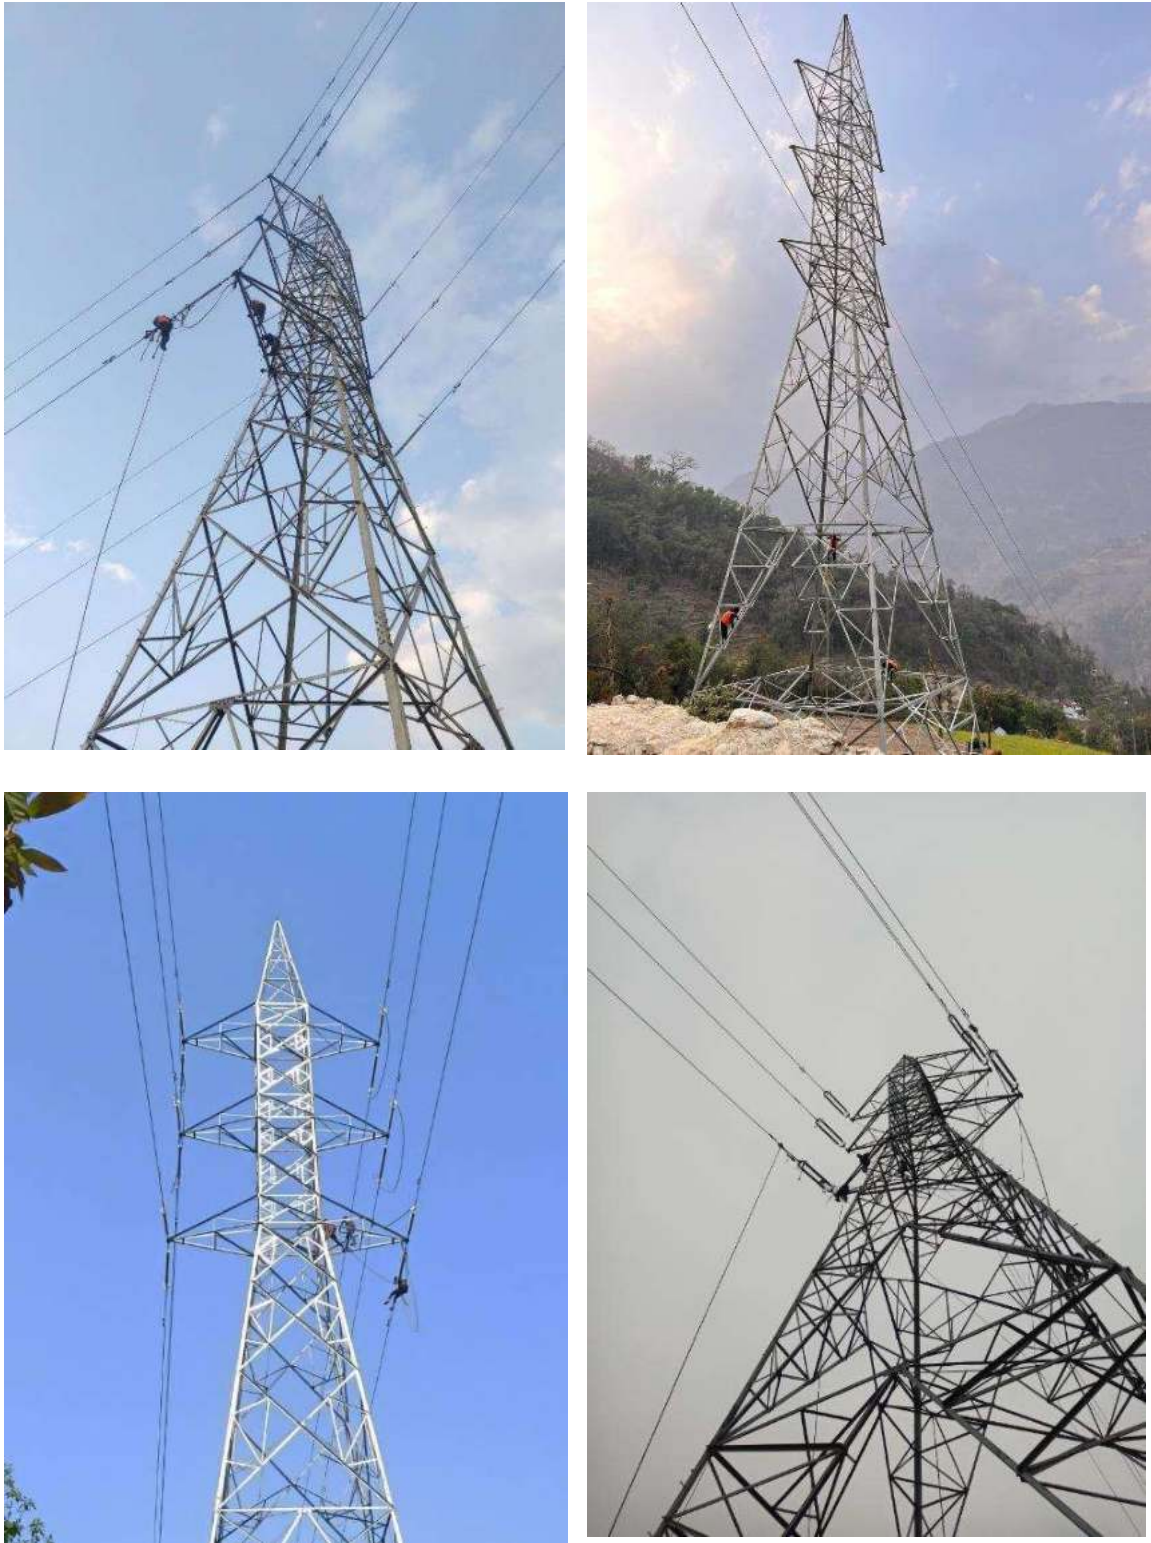
Figure 2-76: Conductor stringing works at various angle points
