MIDDLE TAMOR HYDROPOWER PROJECT (73 MW)

PROGRESS REPORT

(June 2023)

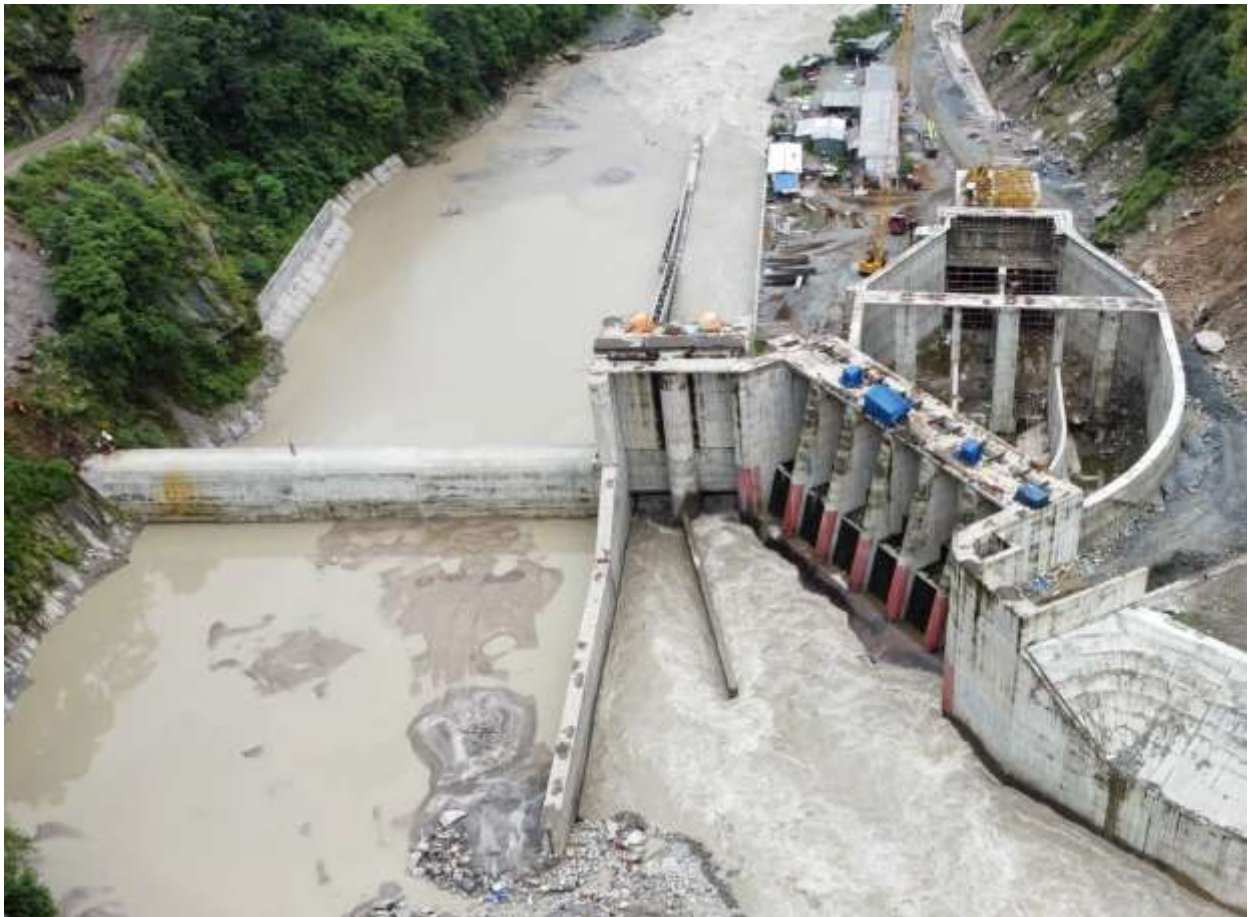
Figure 2-4: Aerial view of Headworks

The Main Civil Contractor has been carrying out concreting works at the headworks region through Nepali sub-contractors. The construction works of weir and stilling basin have been completed as of June 2022 along with downstream floodwall. Further, the construction of undersluice and intake (orifice structure) has been completed as of February 2023 along with fish ladder. The construction of Intake canal has also been completed in March 2023. In addition to this, approximately 99% of construction works at u/s floodwall and 98% at gravel trap have been completed. The construction of conveyance tank and approach pipe is in the final stage of completion. About 98% concreting works at the conveyance tank and 50% at approach pipe casing has been completed. Details of construction work area are described hereunder.

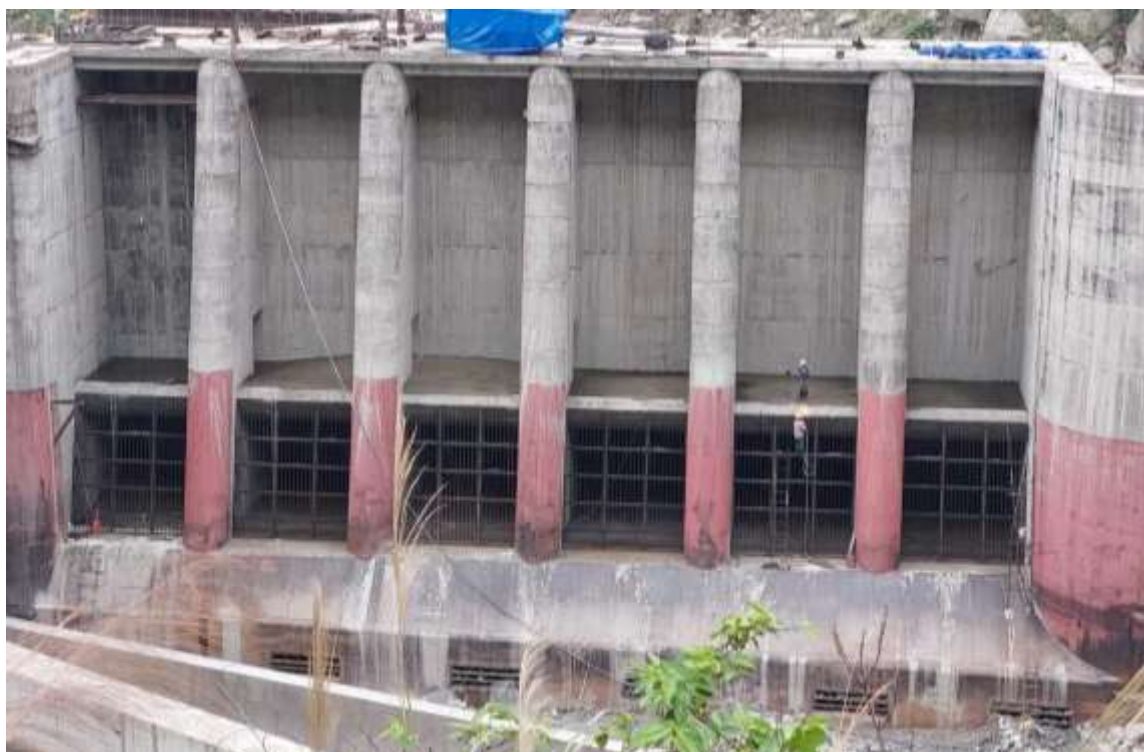
Figure 2-5: A front view of intake orifices

Structure	Total volume	Completed volume	% Complete
Intake (Orifice)	8,178.66	8,095.58	99%
Intake canal	2,704.64	2,704.64	100%
Gravel trap	4,808.93	4,741.46	99%

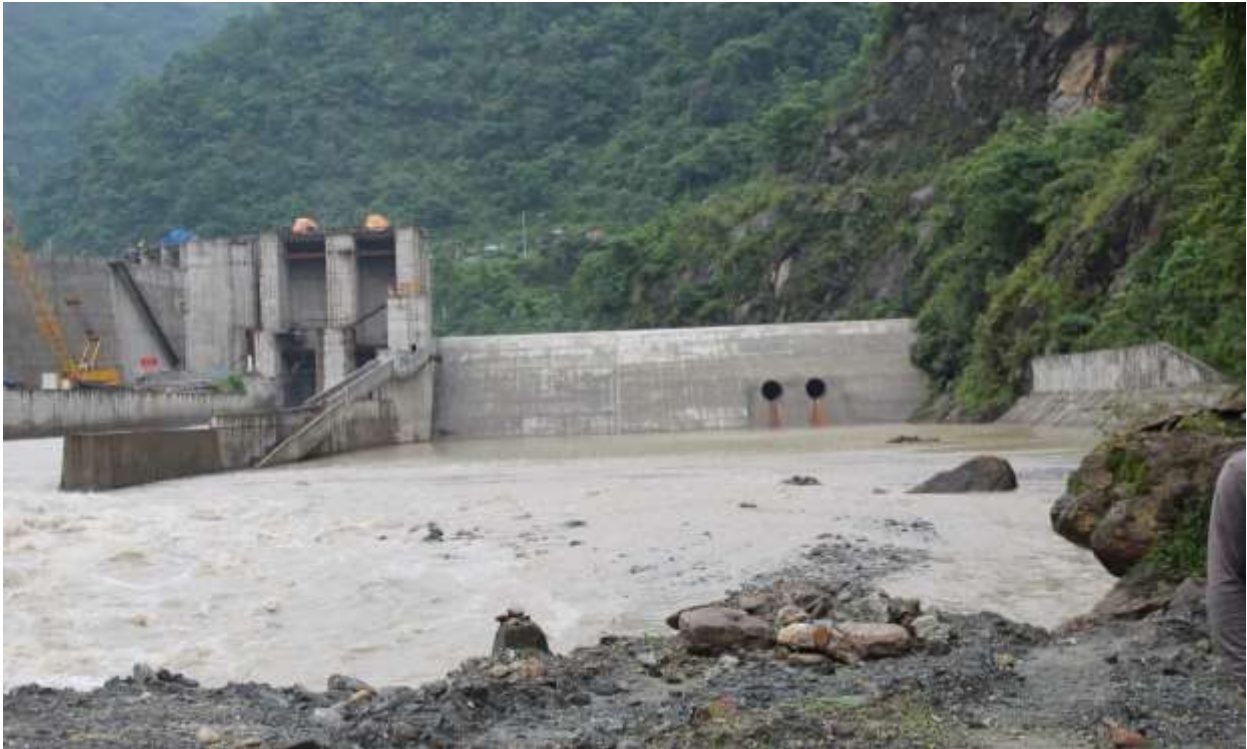
Figure 2-6: A view of weir from upstream

S.N	Structure	Estimated Quantity (m ³)	Progress (m ³)	%Completed
1	Weir Body	17,342.23	17,342.23	100%
2	Stilling Basin	10,847.81	10,847.81	100%
3	U/S Slab and Cutoff	2,096.30	2,096.30	100%
	Total	30,086.34	30,086.34	100%

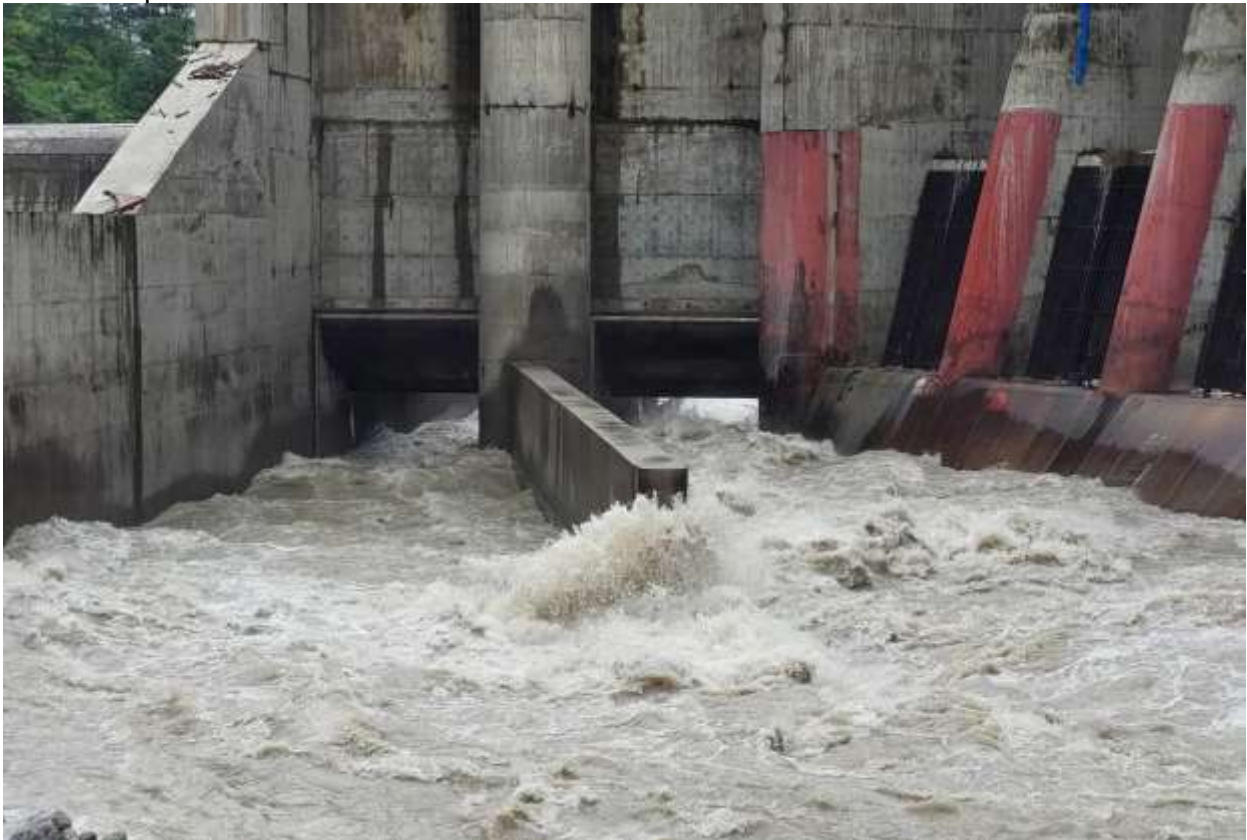
Figure 2-7: Gate installation works at undersluice

The construction of undersluice has been completed as of February 2023 along with the construction of the fish ladder. About 19,327 m³ of concrete was poured in the Undersluice portion till the completion.

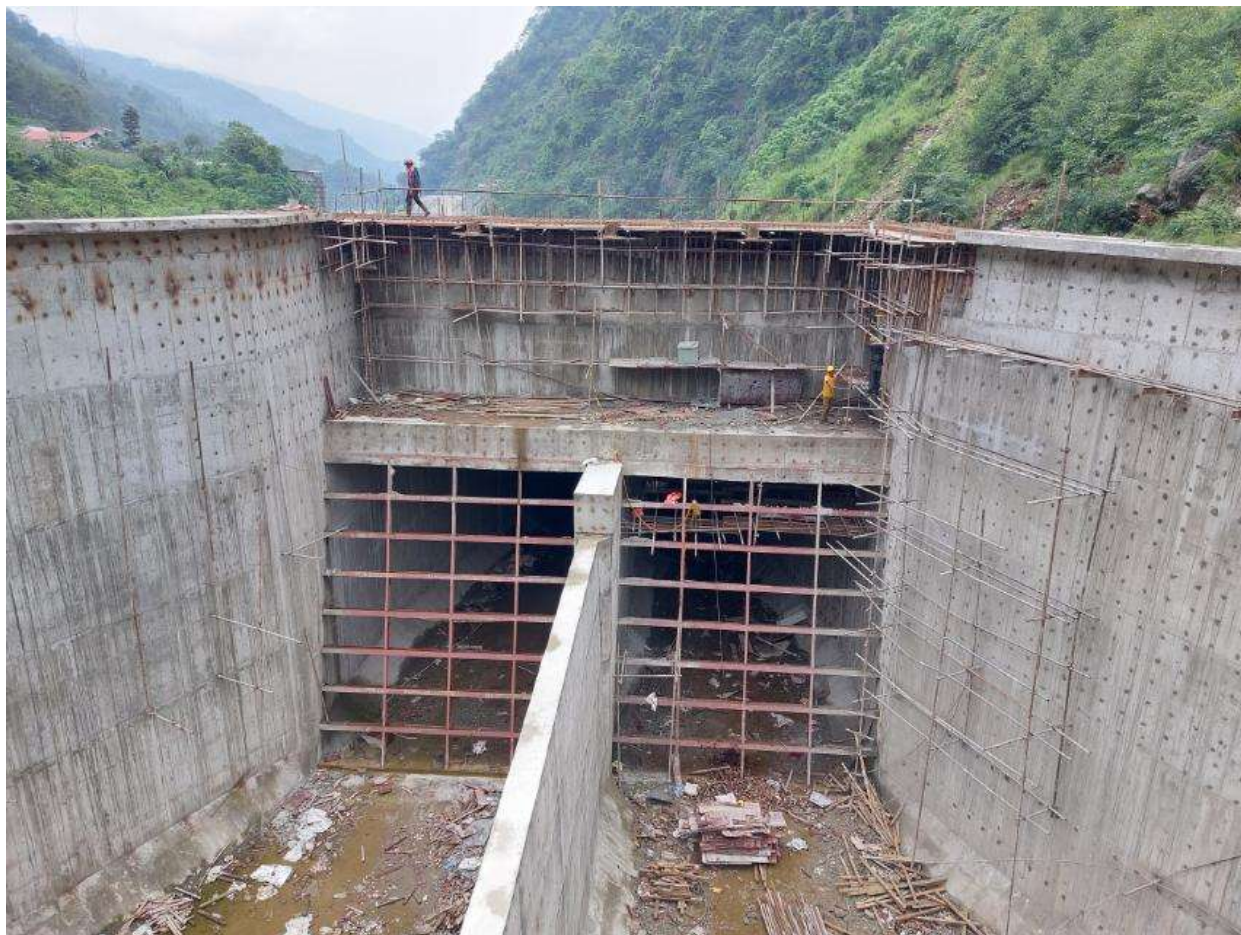
Figure 2-8: Final stage concreting works at the conveyance tank right top slab

Till date, about 7,700 m³ of concrete has been poured at the conveyance tank region. The concreting works at the top slab and side walls of the hill side panel is going on. Almost 98% of concreting works has been completed in the conveyance tank section. The concrete works at the conveyance tank is scheduled to be completed by June 2023.

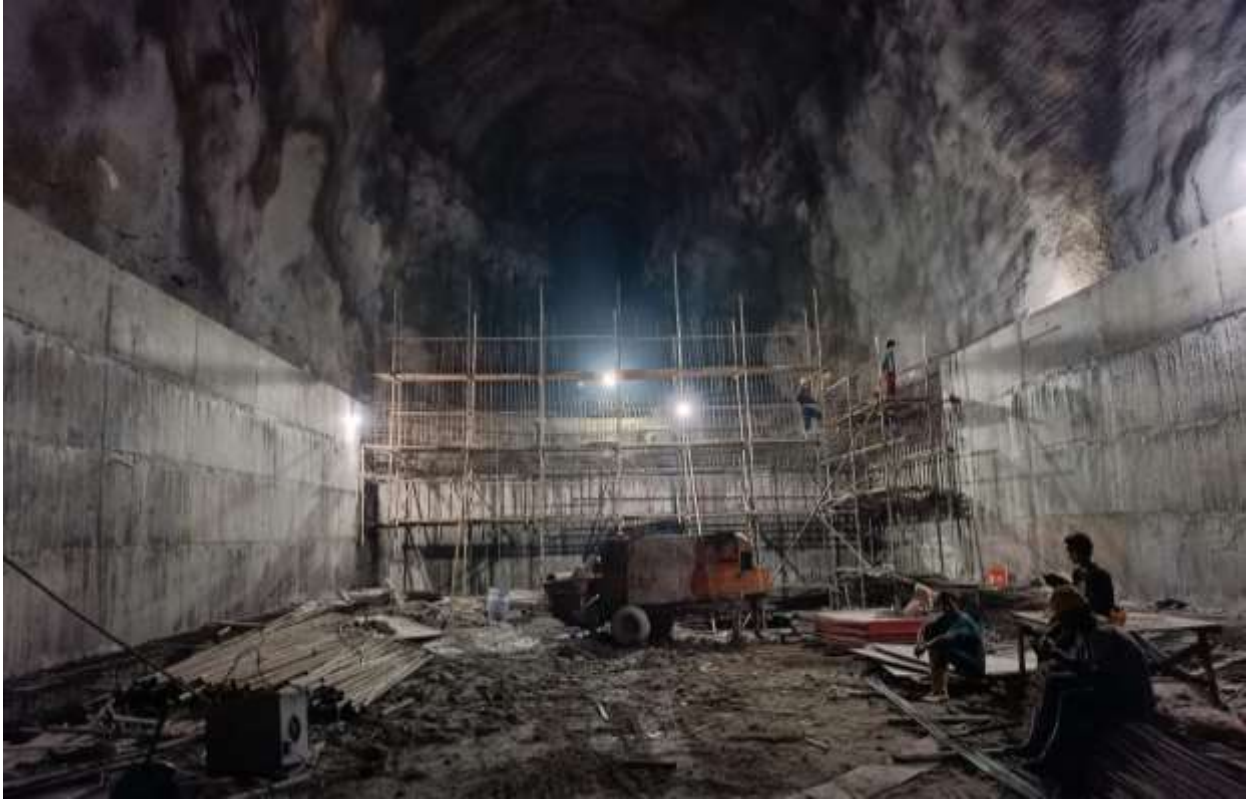
Figure 2-11: A view of concrete lining works being carried out at Settling basin 01

01 has been completed as of February 2023. Till date almost 29,669.13 m³ excavation has been carried out in SB-01. Further, the concrete lining works have already been commenced. Till date more than 80% of design concrete lining works at the walls of the settling basin 01 has been completed.

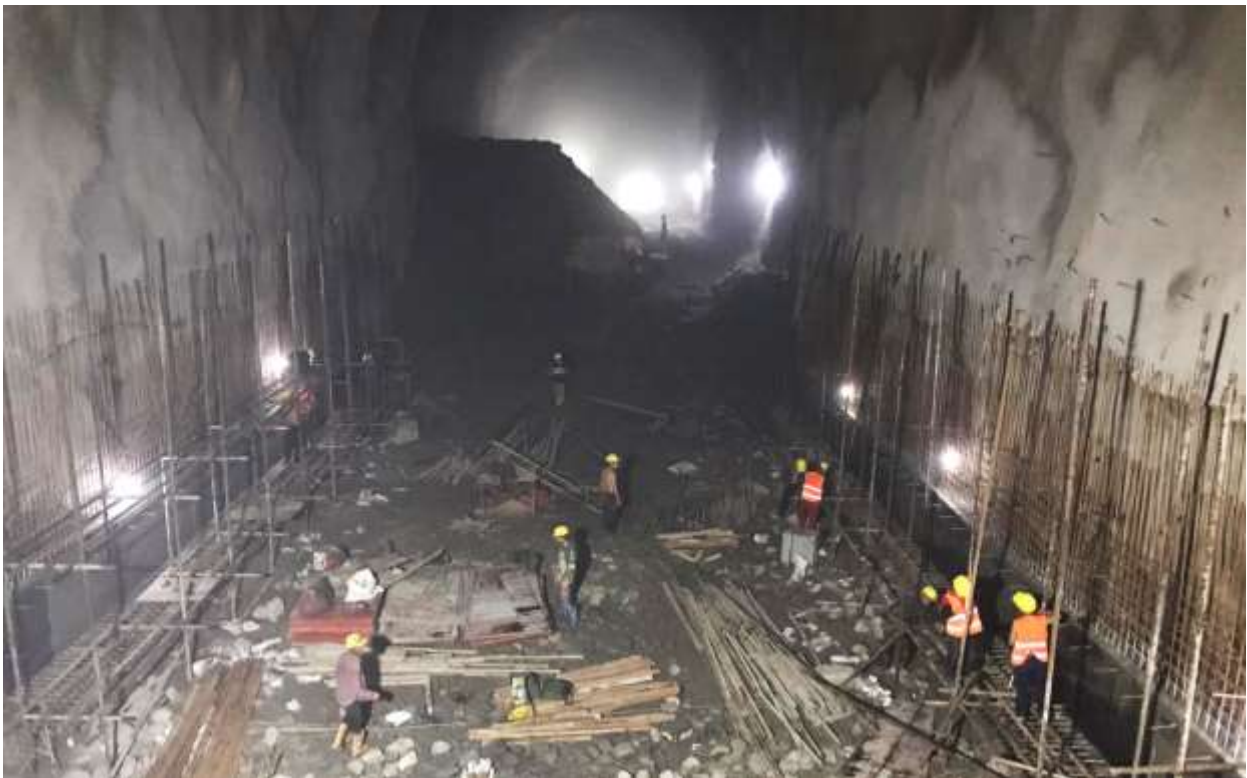
Figure 2-12: Concreting works at the settling basin bay 02 walls

The settling basin bay 02 is 100 m long along with 35 m long inlet transition zone and 15 m long outlet transition zone. The settling basin bay is 13.5 m wide and 17.5 m high. The excavation of settling basin bay 02 has been completed as of May 2023. Moreover, shotcrete works with wire mesh is being applied near the spring line region of SB-02.

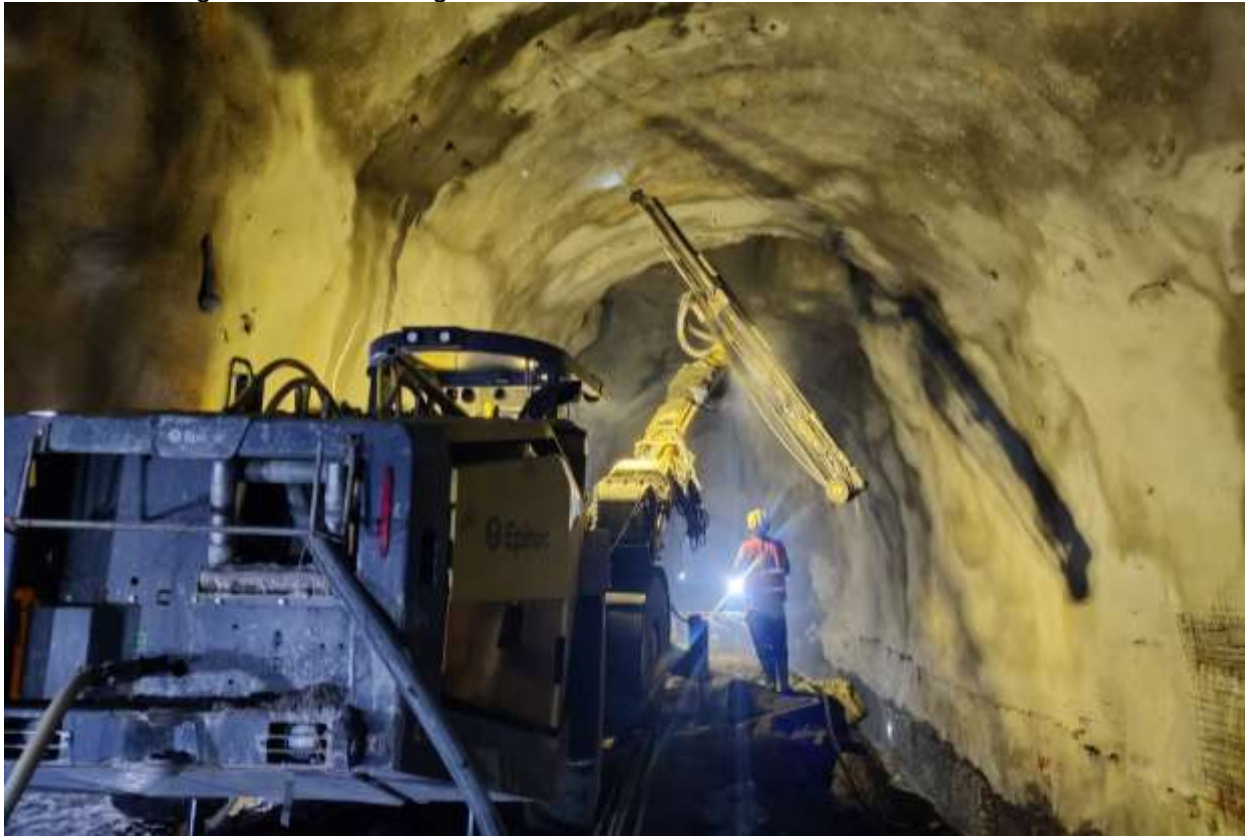
Figure 2-14: Additional Rock bolt installation in SB 03

With this, the Contractor has already excavated almost 84% of earthwork volume in these three fronts of settling basin in benching form.

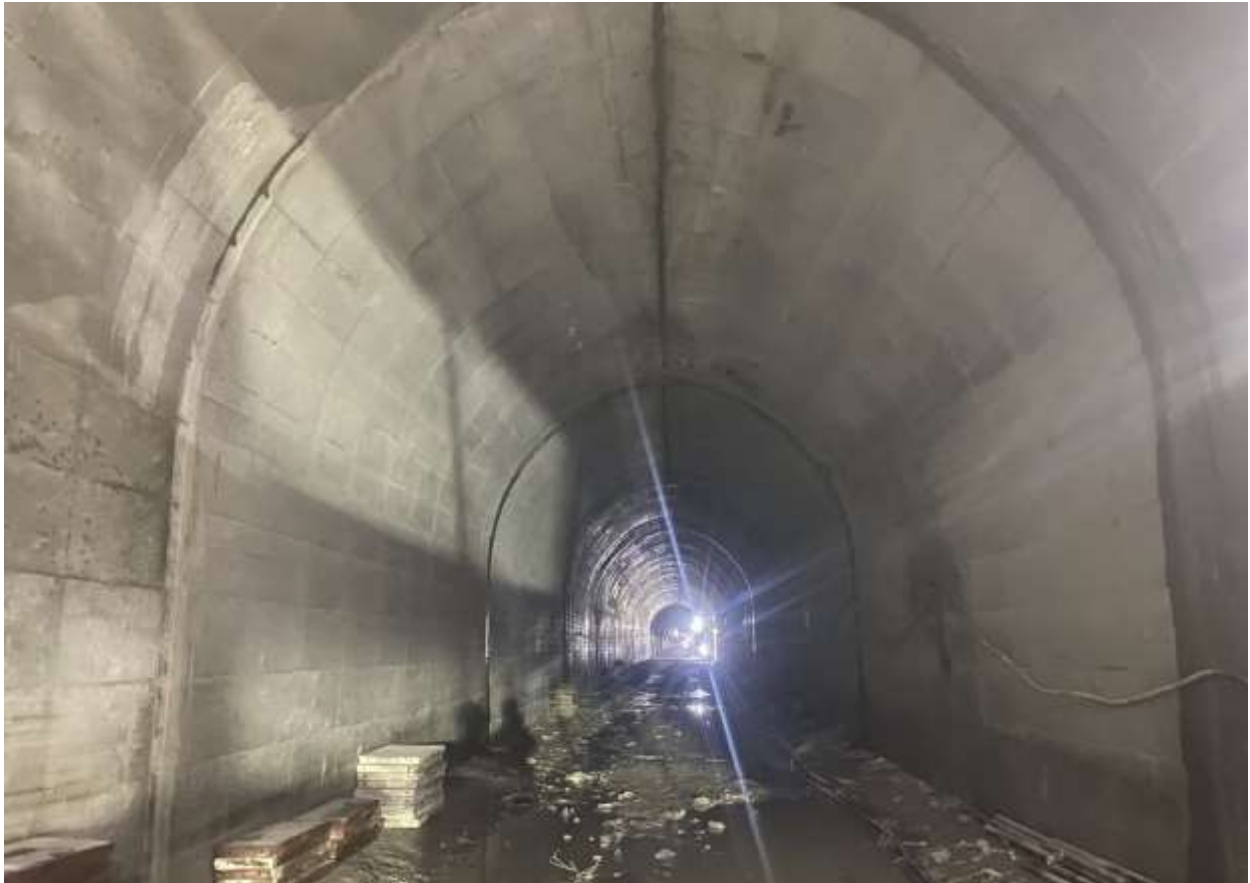
Figure 2-16: A section of HRT with concrete full lining

Particulars	Total length (m)	Length of concreting works (m)	Completion %
Invert concrete	3,300.00	3,300.00	100%
Wall lining	2,700.00	2,700.00	100%
Full lining	670.00	232.00	37%

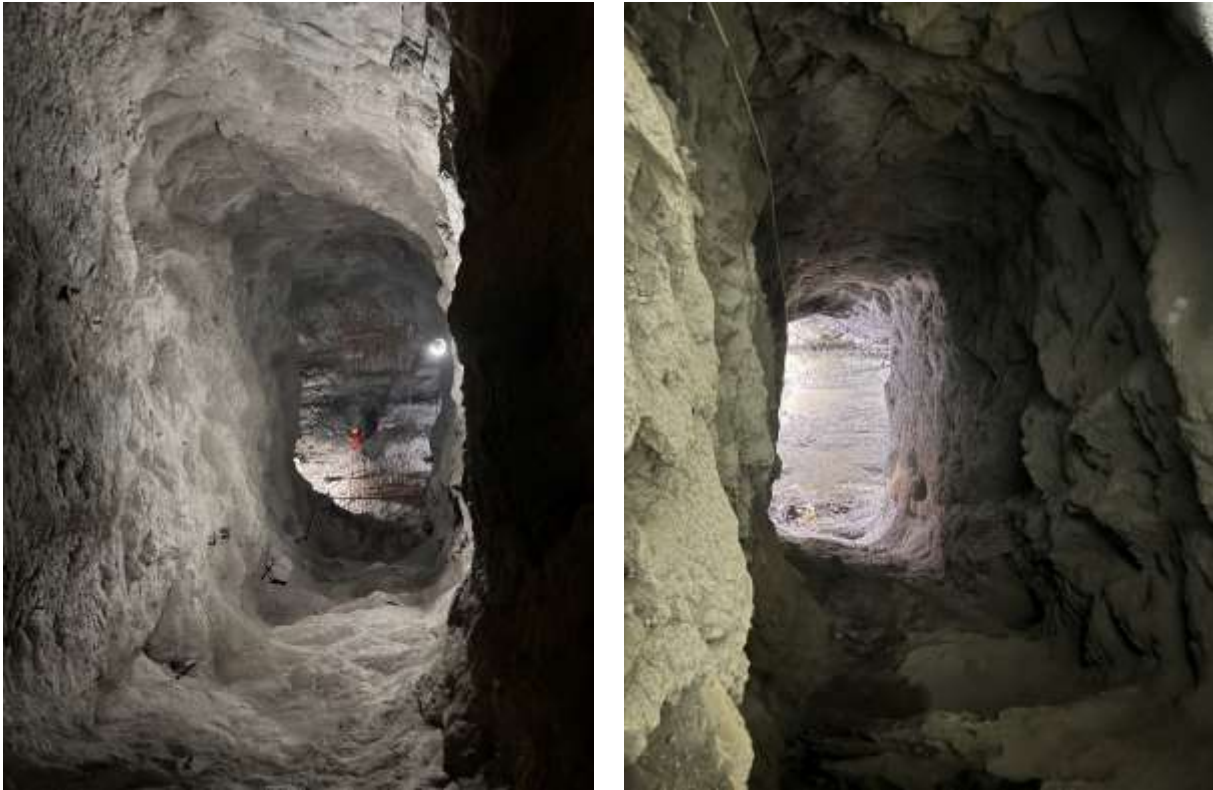
Figure 2-18: Inlet gate shaft 01 (left) and Inlet gate shaft 02 (right)

The contractor is carrying out excavation of inlet gate shaft of settling basin-01 from the bottom and is in final stage of completion. The excavation of inlet gate shaft of settling basin-02 has already been completed as of February 2023.

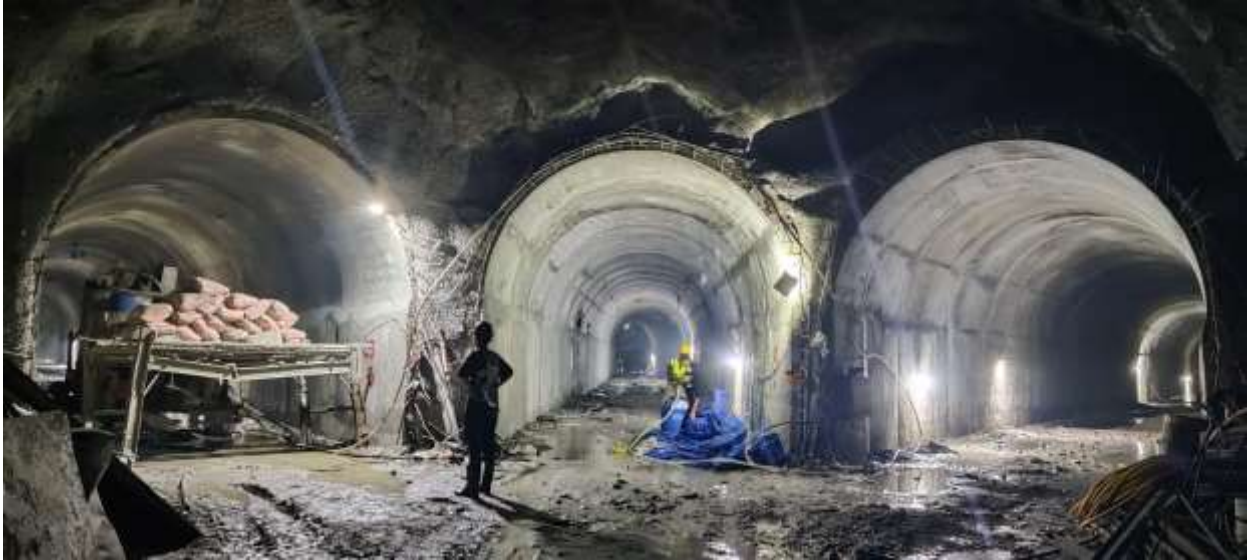
Figure 2-18: A view of connecting tunnel junction point

The full concrete lining works at connecting tunnel 03 from the end of outlet transition zone of SB-03 to connecting tunnel junction point has been completed.

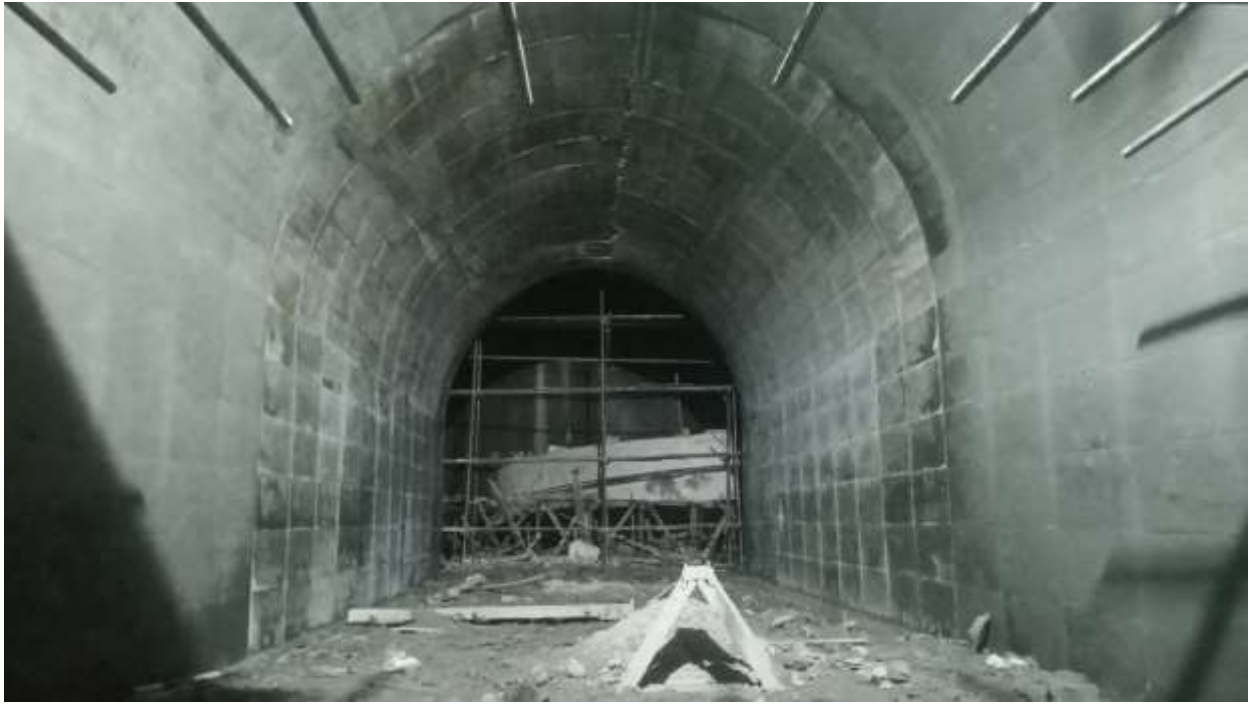
Figure 2-20: A view of full lining concrete at connecting tunnel to Surge Shaft

Further, the full concrete lining works at the connecting tunnel from HRT to Surge shaft has already begun and is being carried out at a great pace.

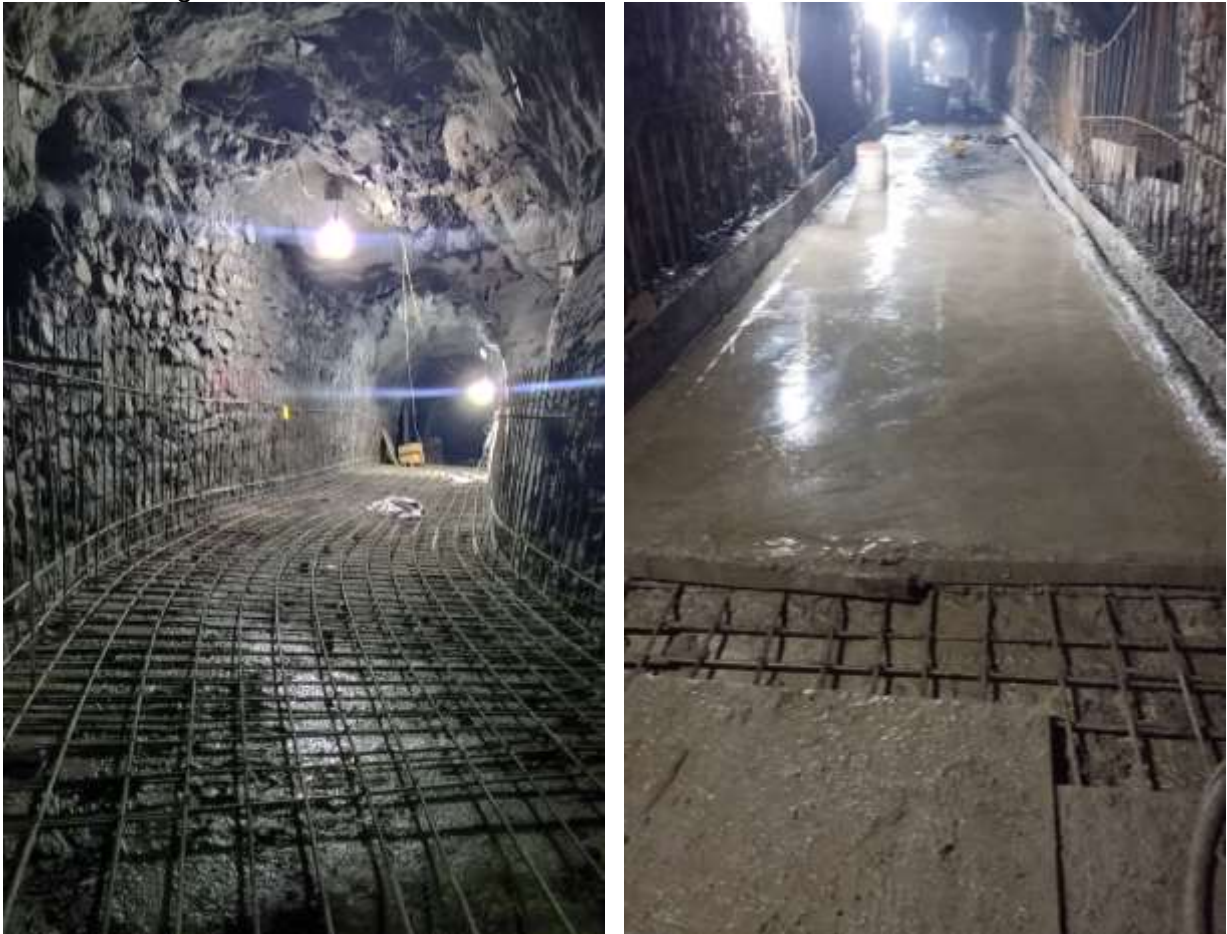
Figure 2-21: A view of rebar layout at the flushing tunnel

The excavation of 475 meters long sediment flushing tunnel has already been completed as of February 2023. The Contractor is carrying out rebar layout and simultaneous concrete pouring at the invert region.

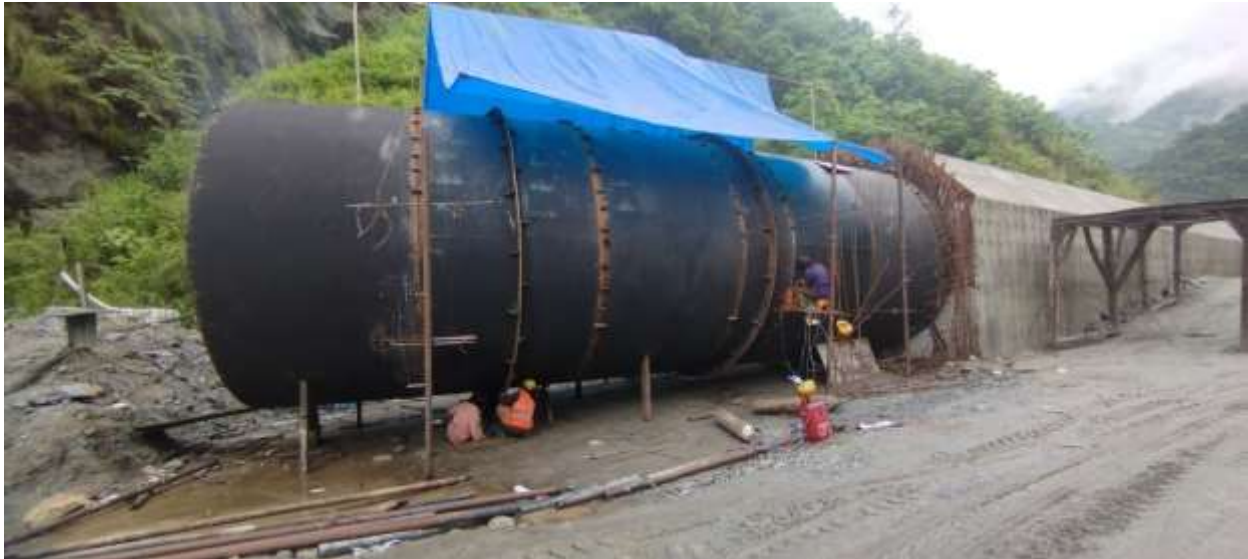
Figure 2-28: Installation of head race bend

Erection of bend 03 have been completed and the welding works has been ongoing.

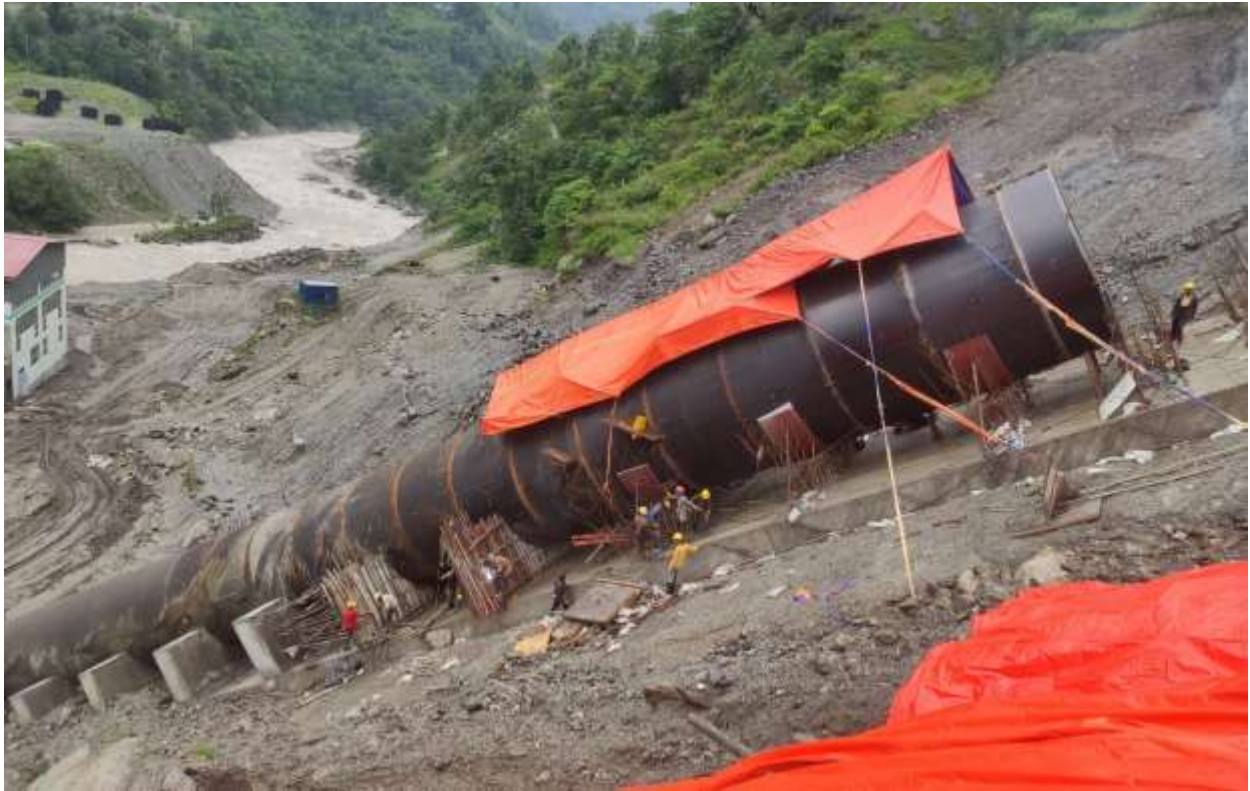
Figure 2-29: Erection of penstock pipes

Straight Pipes	Up to previous month	This Month
Cutting	141	X
Rolling	125	7
Fitting	60	1
Welding	60	1
Inspection	60	1
Blasting	58	4
Painting	58	4
Erection	37	16

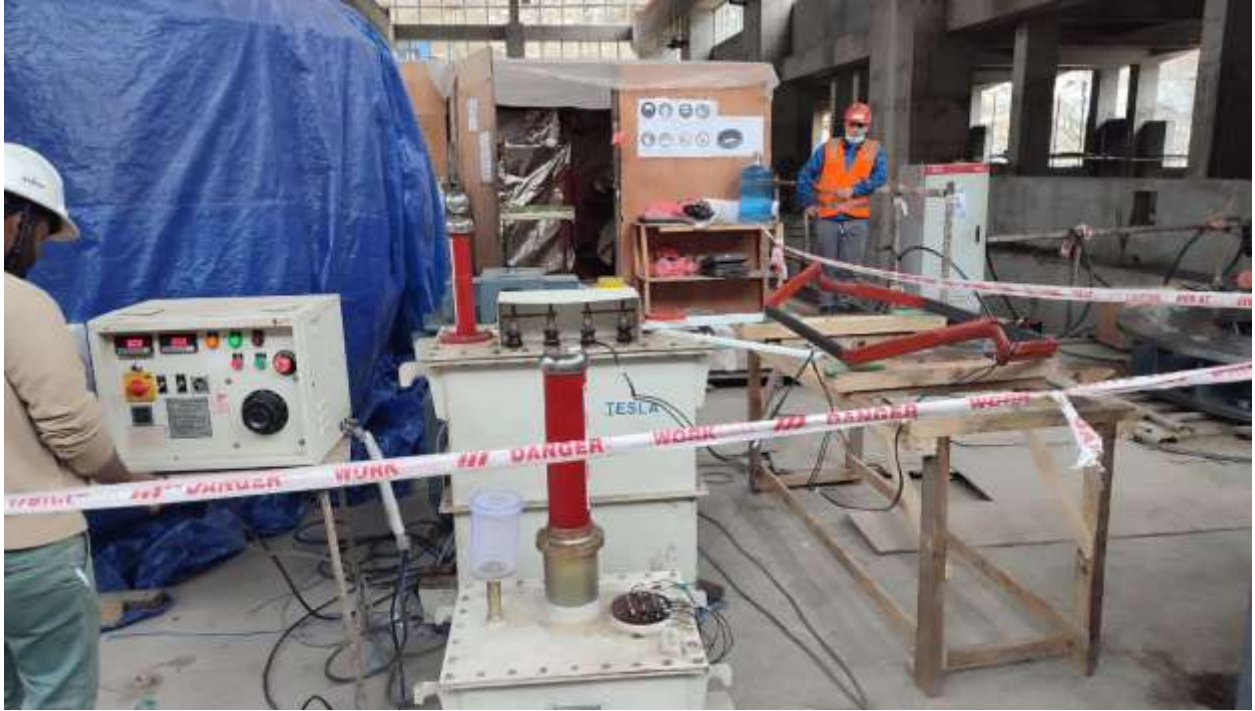
Figure 54: High voltage test of stator coil

The installation of critical turbine and generator components is progressing rapidly with the preassembly of bottom ring, guide vane, head cover and lower bracket. In addition, the assembly of split stator and rotor for the generator has also been completed. The high voltage testing of installed stator coils and rotor has been successfully completed.

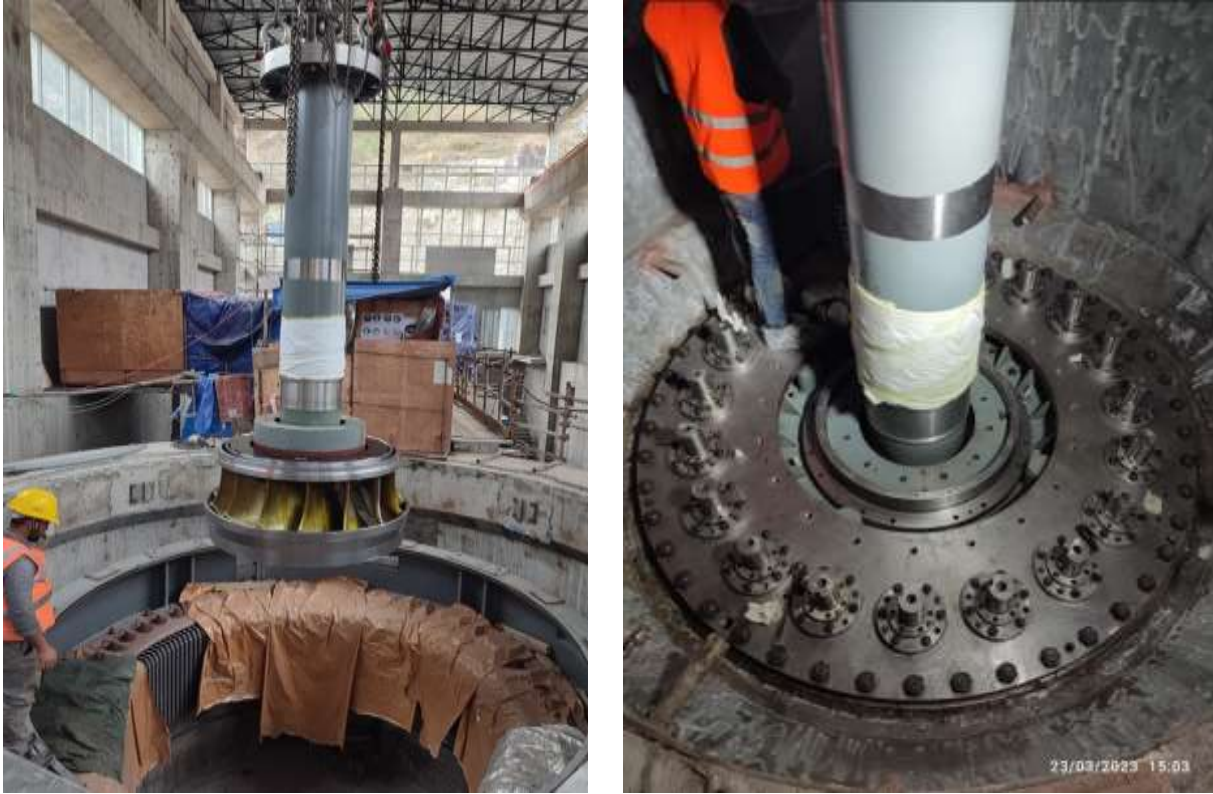
Figure 2-43: Lowering of runner with main shaft in unit 2 (left) and final assembly of bottom ring, guide vane, head cover and main shaft with runner (right)

The final assembly of bottom ring, guide vane, main shaft with runner, head cover and air cooler has been completed, while the lower bracket, split stator parts and upper bracket have been lowered and preassembled. Additionally, the rotor of unit one has been parked in unit two to facilitate the rotor assembly work of the next unit. A few photographs are attached below depicting the work progress.

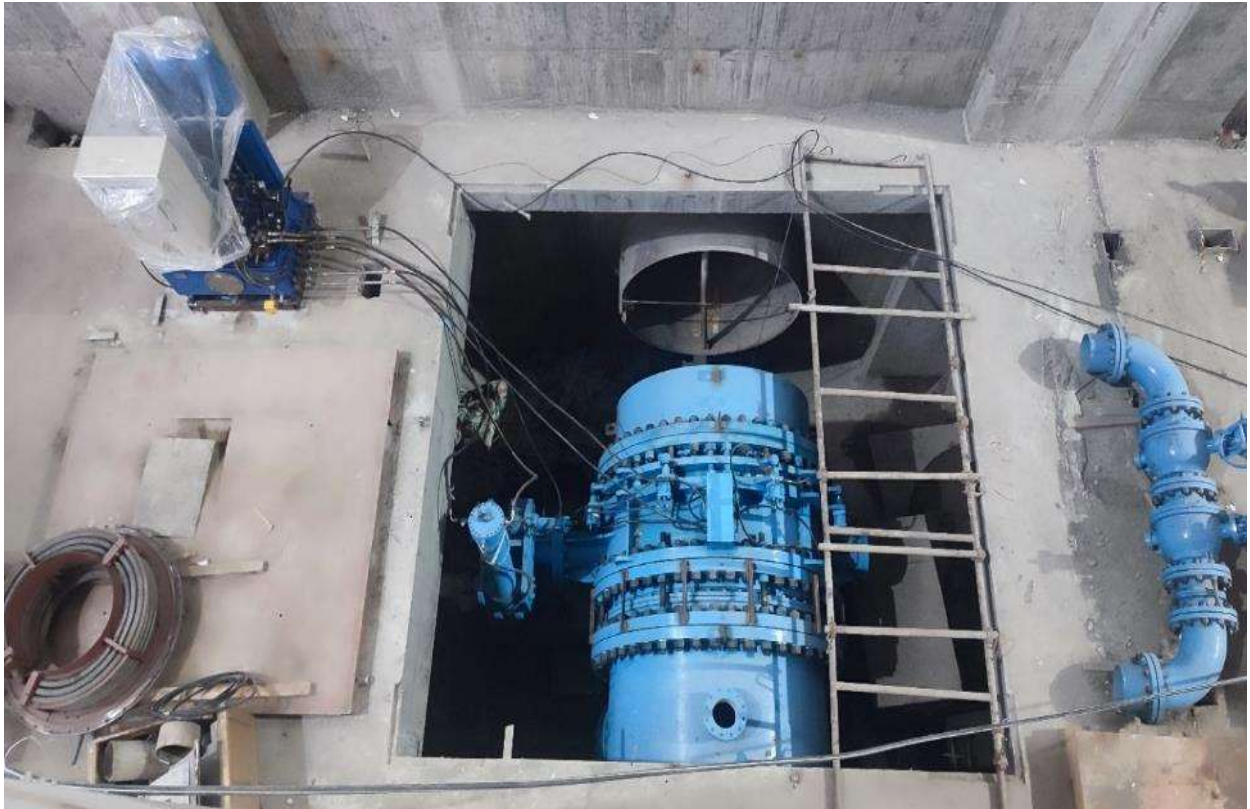
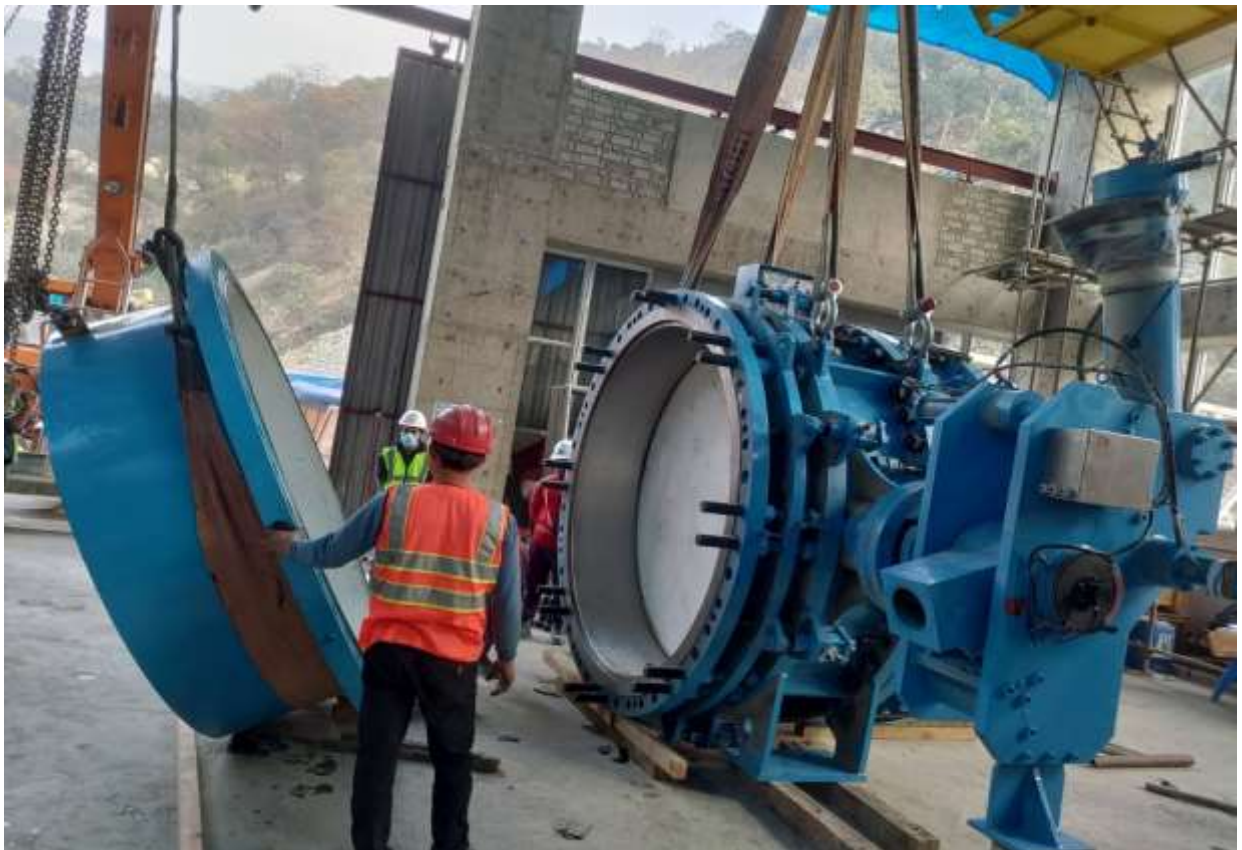
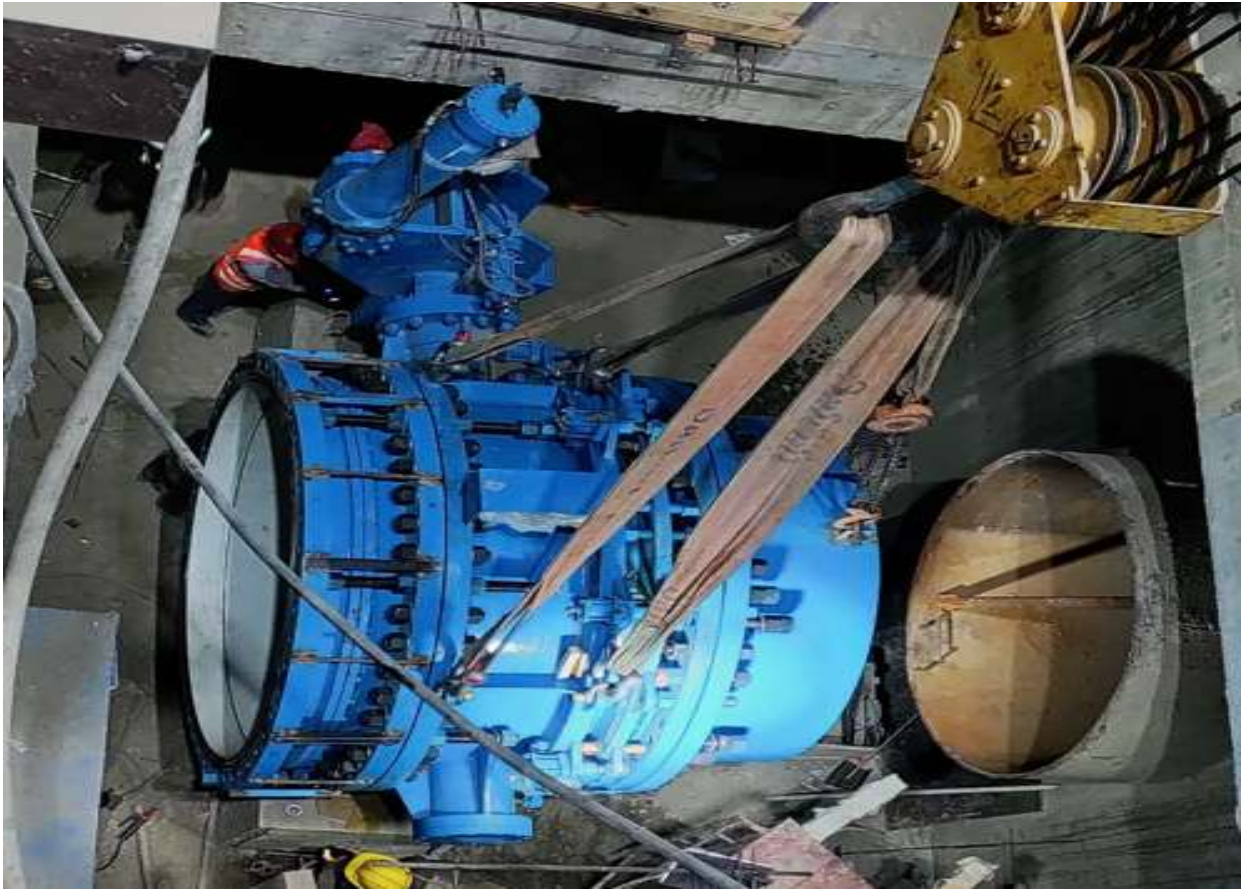
All 4 units of Main inlet valve have been successfully delivered to the site, and as of today, they have been lowered into their respective positions, with the downstream side welding of the unit 1 and unit 2 now completed. Few photographs of different stages of assembly of Main inlet valve are shown below:

Figure 2-47: Unit 4 MIV lowered to its position

Figure 2-48: Unit 2 MIV assembled at Service bay

Figure 2-49: Unit 03 MIV lowered in to its position

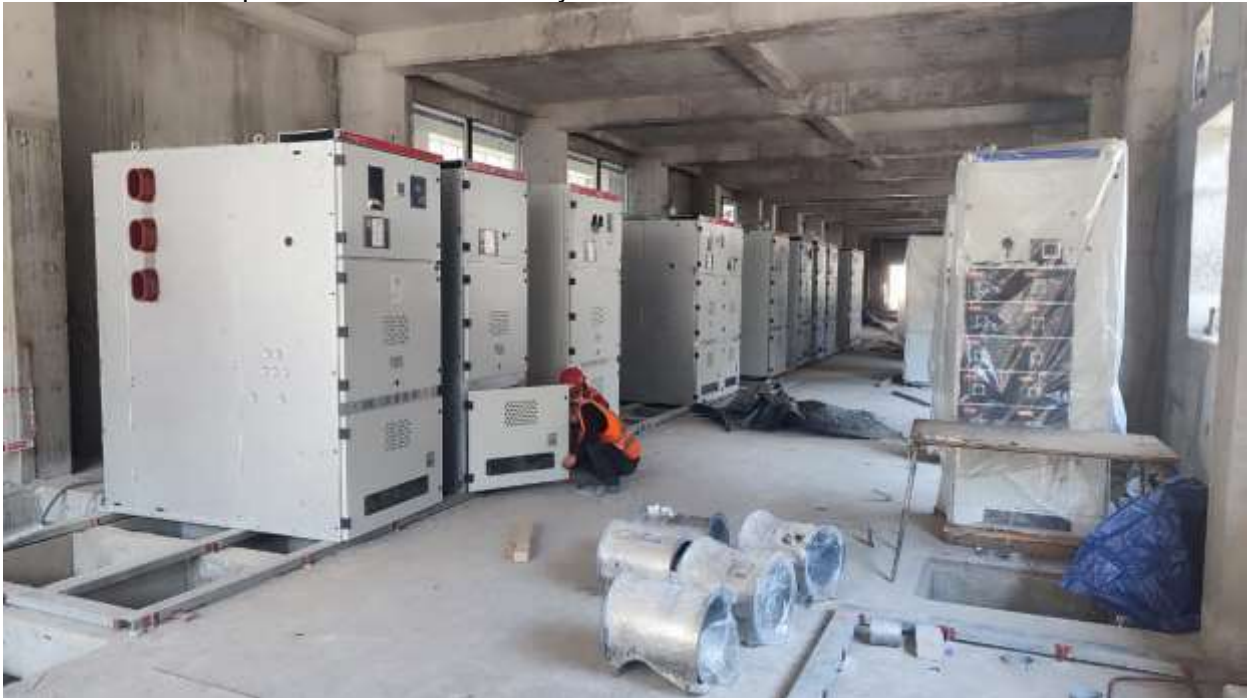
Figure 70: Installation of 11 kV switchgear panels

All the installation works of the embedded parts and pipes for control room have been completed. The installation of panel boards has already been commenced.

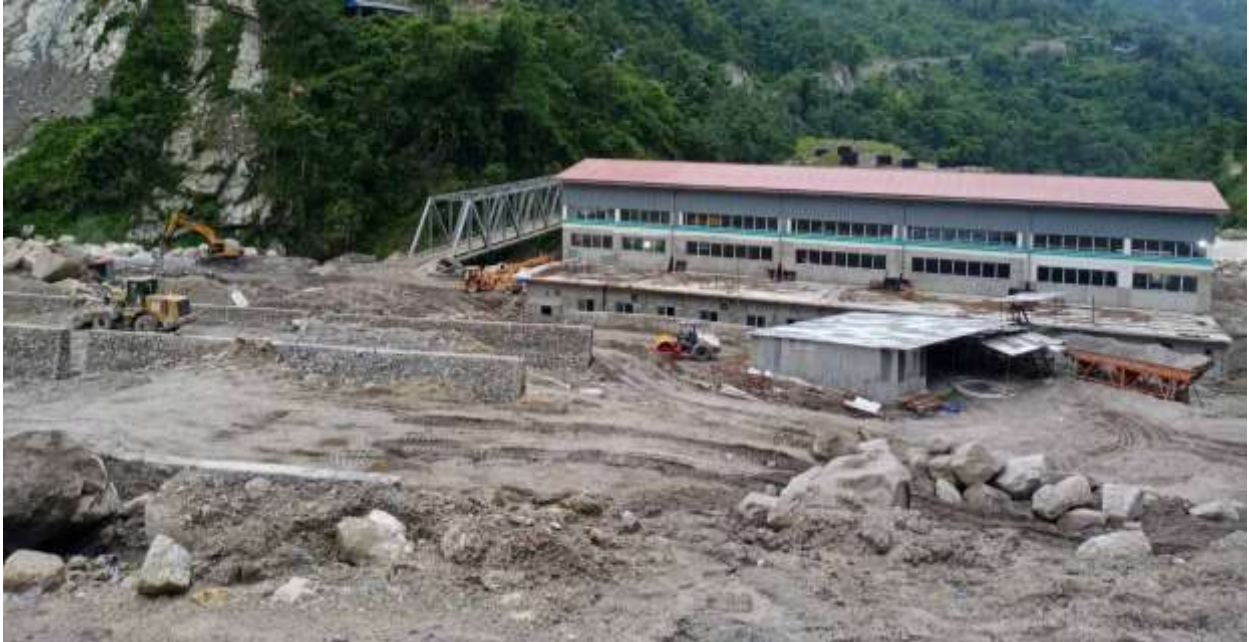
Figure 2-50: Laying of earthing plates

The excavation works and slope protection works are being carried out at the switchyard region of the Project. Currently, laying of grounding flat plates are going on parallel with the main civil works.
